LSI UPDATE & CLOSURE REQUEST

Subj: LSI Update Report - Closure Request

Montgomery Auto Parts - Sherburn, Minnesota
GeoTek #99-913-6 MPCA #00013087

LIMITED SITE INVESTIGATION REPORT
MONTGOMERY AUTO PARTS
SHERBURN, MINNESOTA

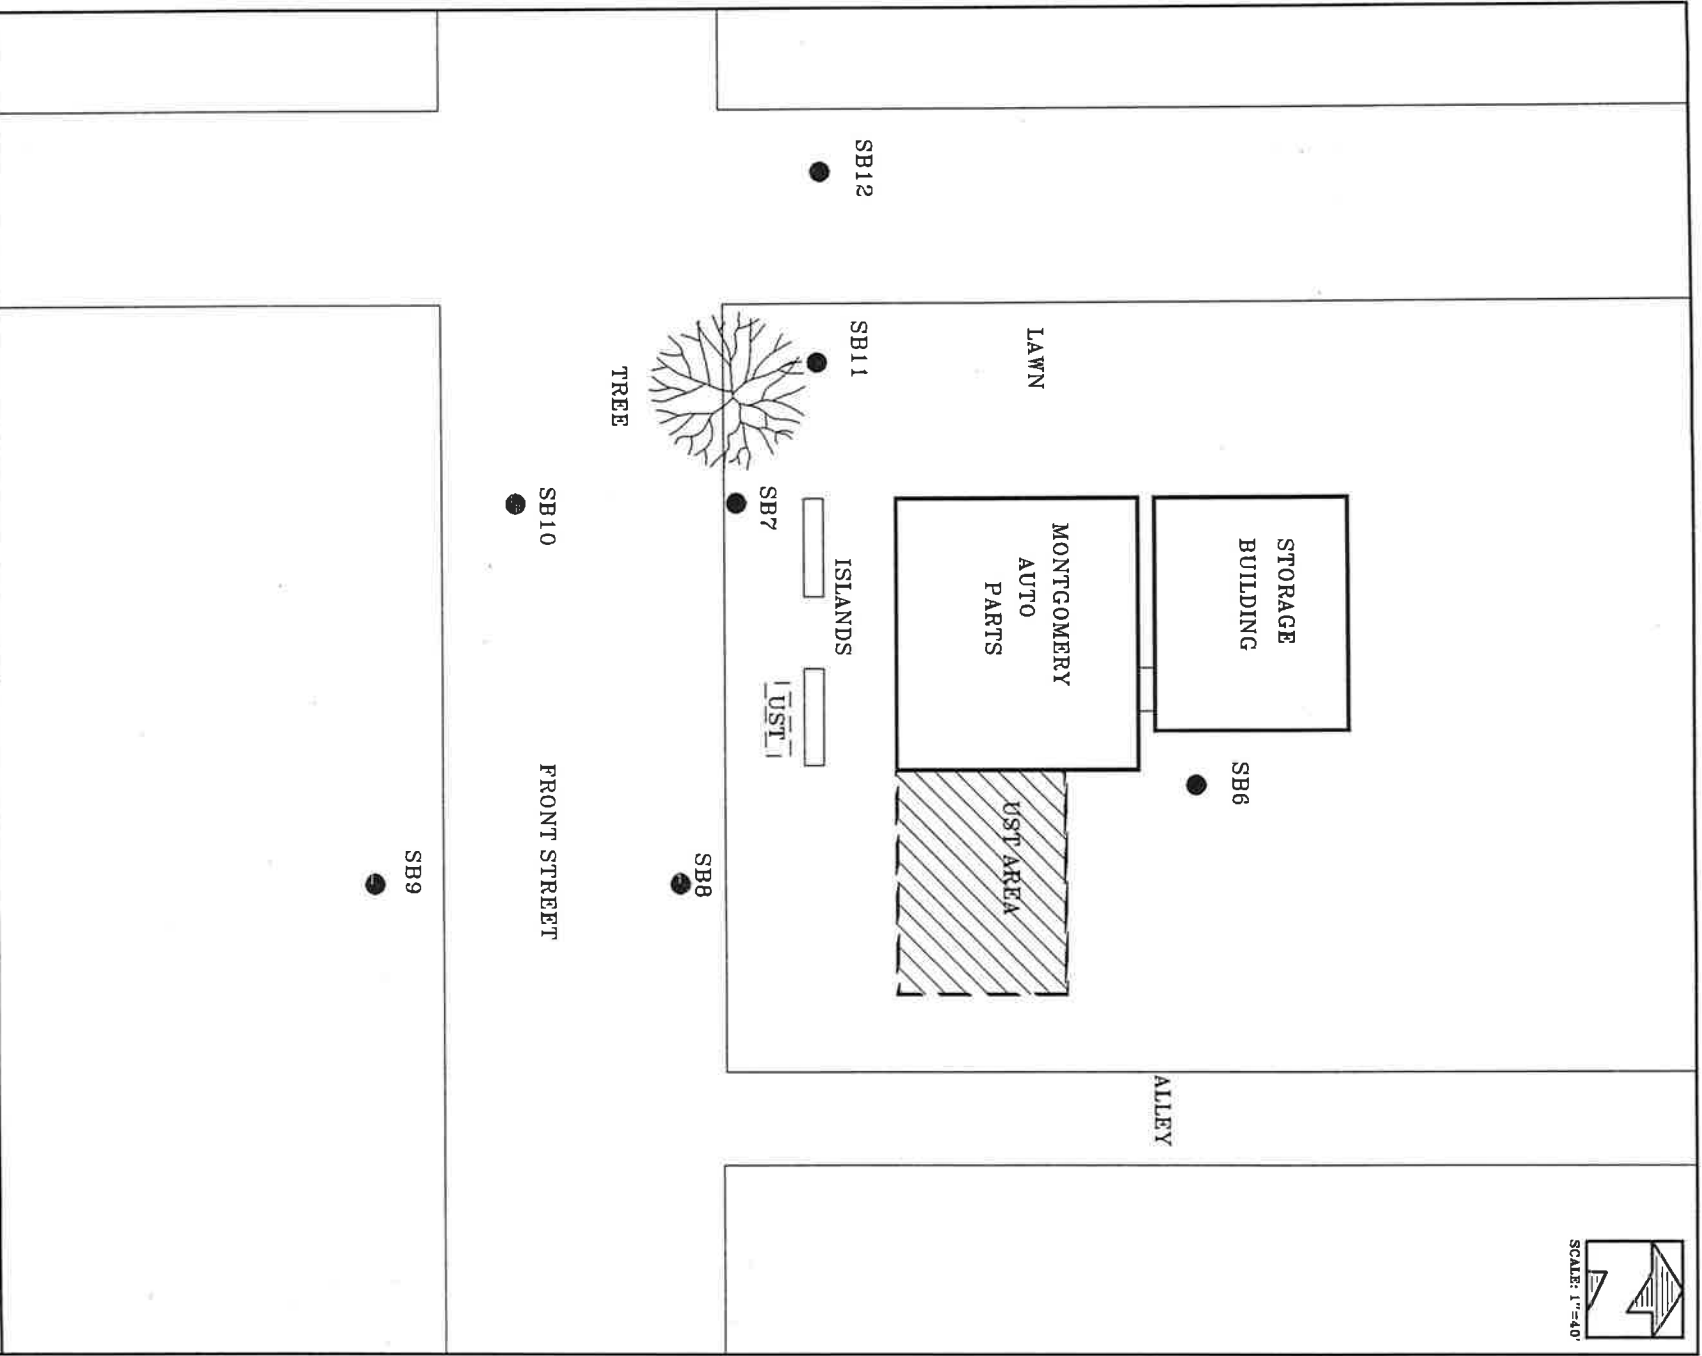
FIGURE 3
SOIL BORING LOCATIONS - APRIL 17, 2003
MONTGOMERY AUTO PARTS
SHERBURN, MN.

The additional work requested included soil borings, soil and groundwater sampling analysis, and a vapor survey of the sewers near the site. Soil borings SB6-SB12 were completed on May 2, 2003, and are indicated on Figure 3. The soil boring logs for SB6-SB12 are provided with this report.

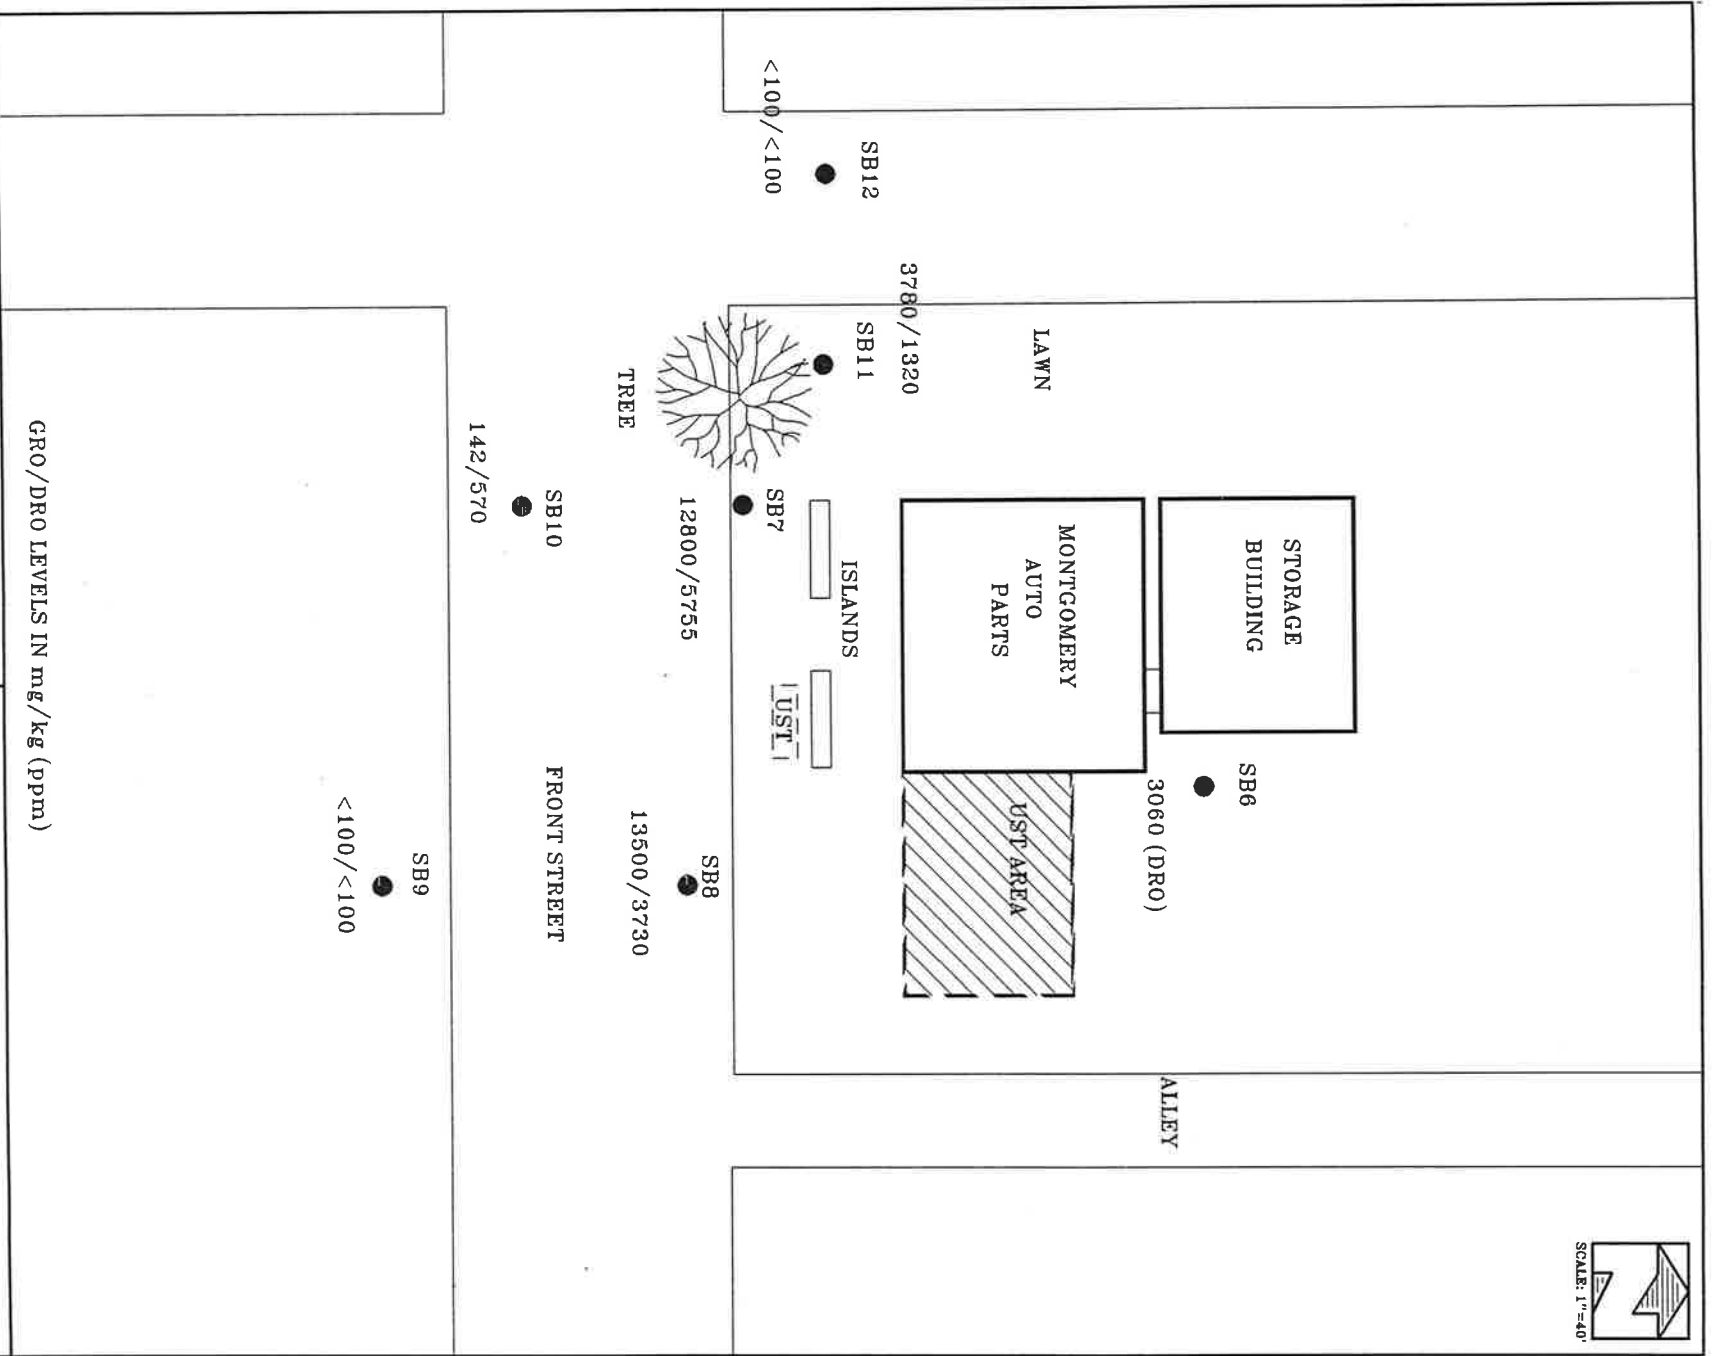
FIGURE 5

The laboratory information for the groundwater samples is included in Table 3. The petroleum (GRO and DRO*) levels detected in groundwater are indicated on Figure 5. The laboratory report for recent (April 17, 2003) groundwater samples is included with this report.

Trace levels of trimethylbenzene were detected in SB6. The greatest concentrations of petroleum derived compounds were detected in the groundwater samples collected from SB7, SB8 and SB11, south (and west) of the release sources. The Benzene and Ethylbenzene levels detected in SB7 and SB8 exceed the Health Risk Limits (HRL's) established by the Minnesota Department of Health.

Petroleum contamination was not detected in groundwater samples collected from SB9 or SB12. It appears that the groundwater contamination detected in SB10 was primarily MTBE.

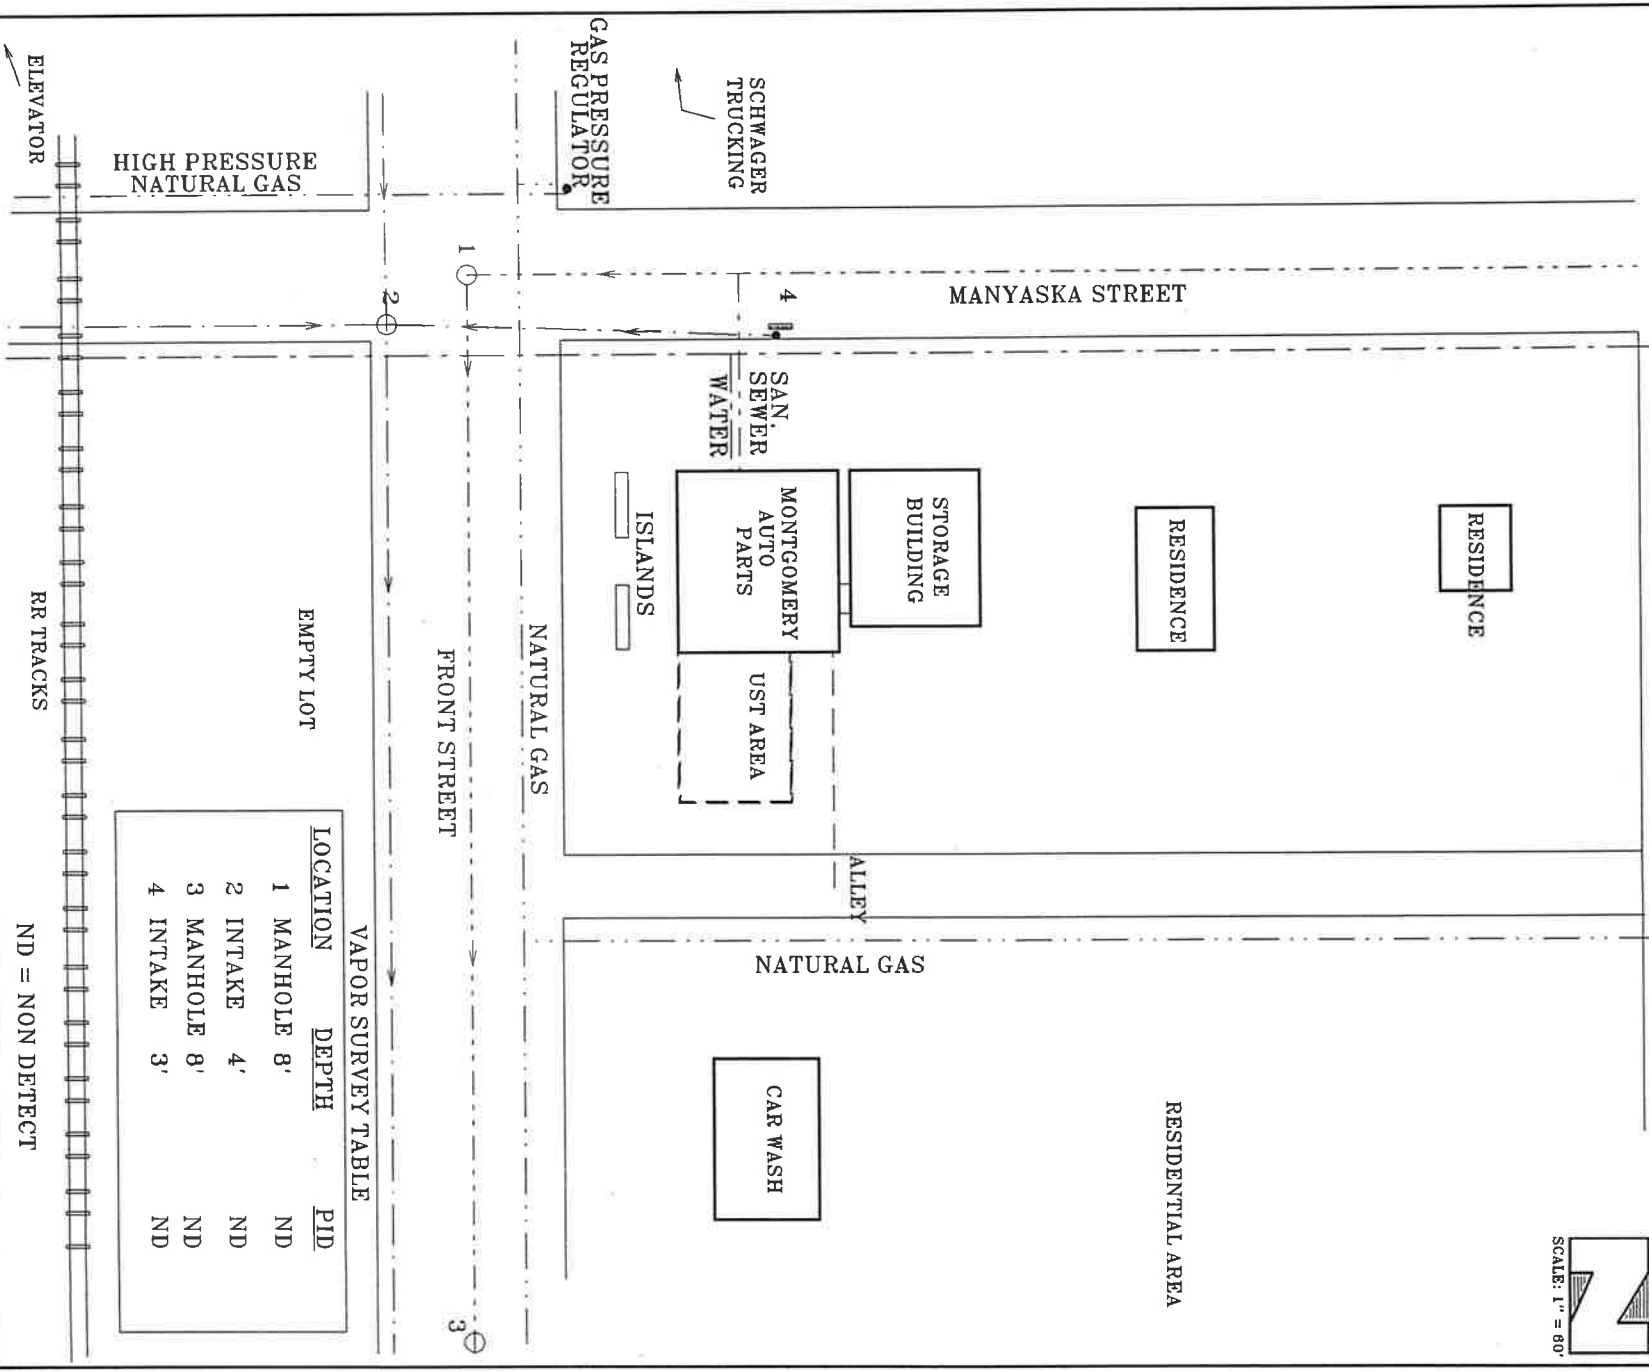
FIGURE 6
UTILITY SURVEY MAP
MONTGOMERY AUTO PARTS
SHERBURN, MN

The site buildings are constructed slab-on-grade and would not be susceptible to petroleum vapor accumulation. The sanitary sewer and storm sewers were scanned for petroleum vapors on the date of drilling. Petroleum vapors were not detected in the locations scanned. The utility locations are indicated on Figure 6.
