PHASE II ENVIRONMENTAL SITE ASSESSMENT

**The Transmission Shop
6958 Cedar Avenue South
Richfield, MN 55423**

File #2477B

August 27, 1997

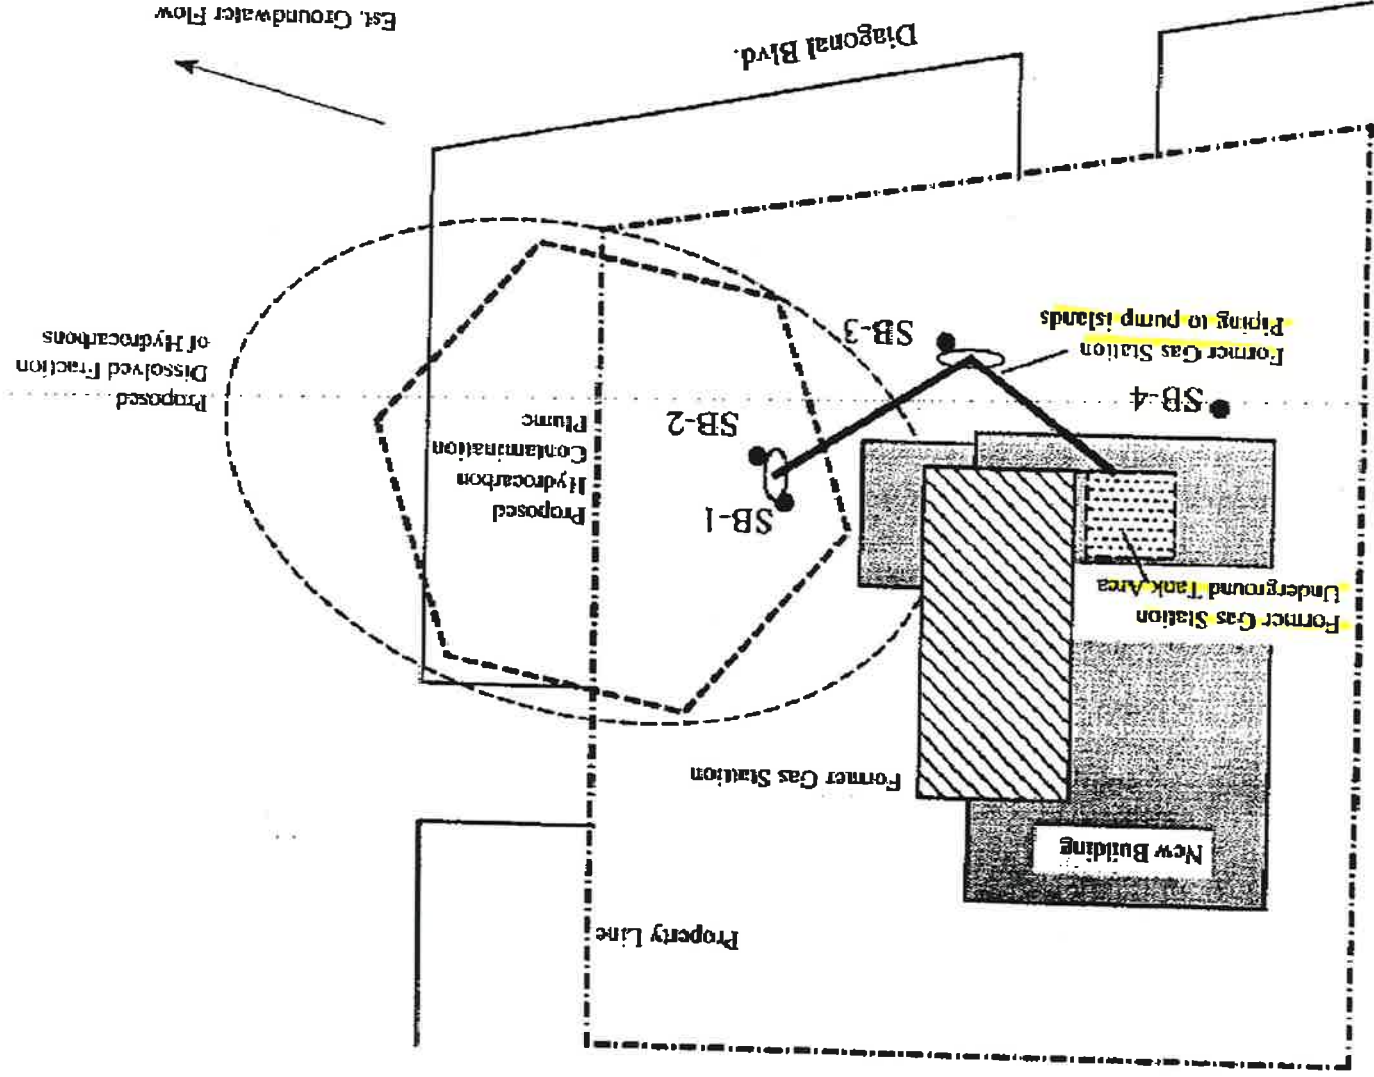
Legend 1" = 30'	Figure 1 Soil Boring Locations Bloomington Quadrangle 6958 Cedar Ave. South Richfield, MN 55423

The results of this study identified elevated concentrations of petroleum contamination in the soils below the surface near the eastern border of the property where a gasoline dispenser island may have once been located.

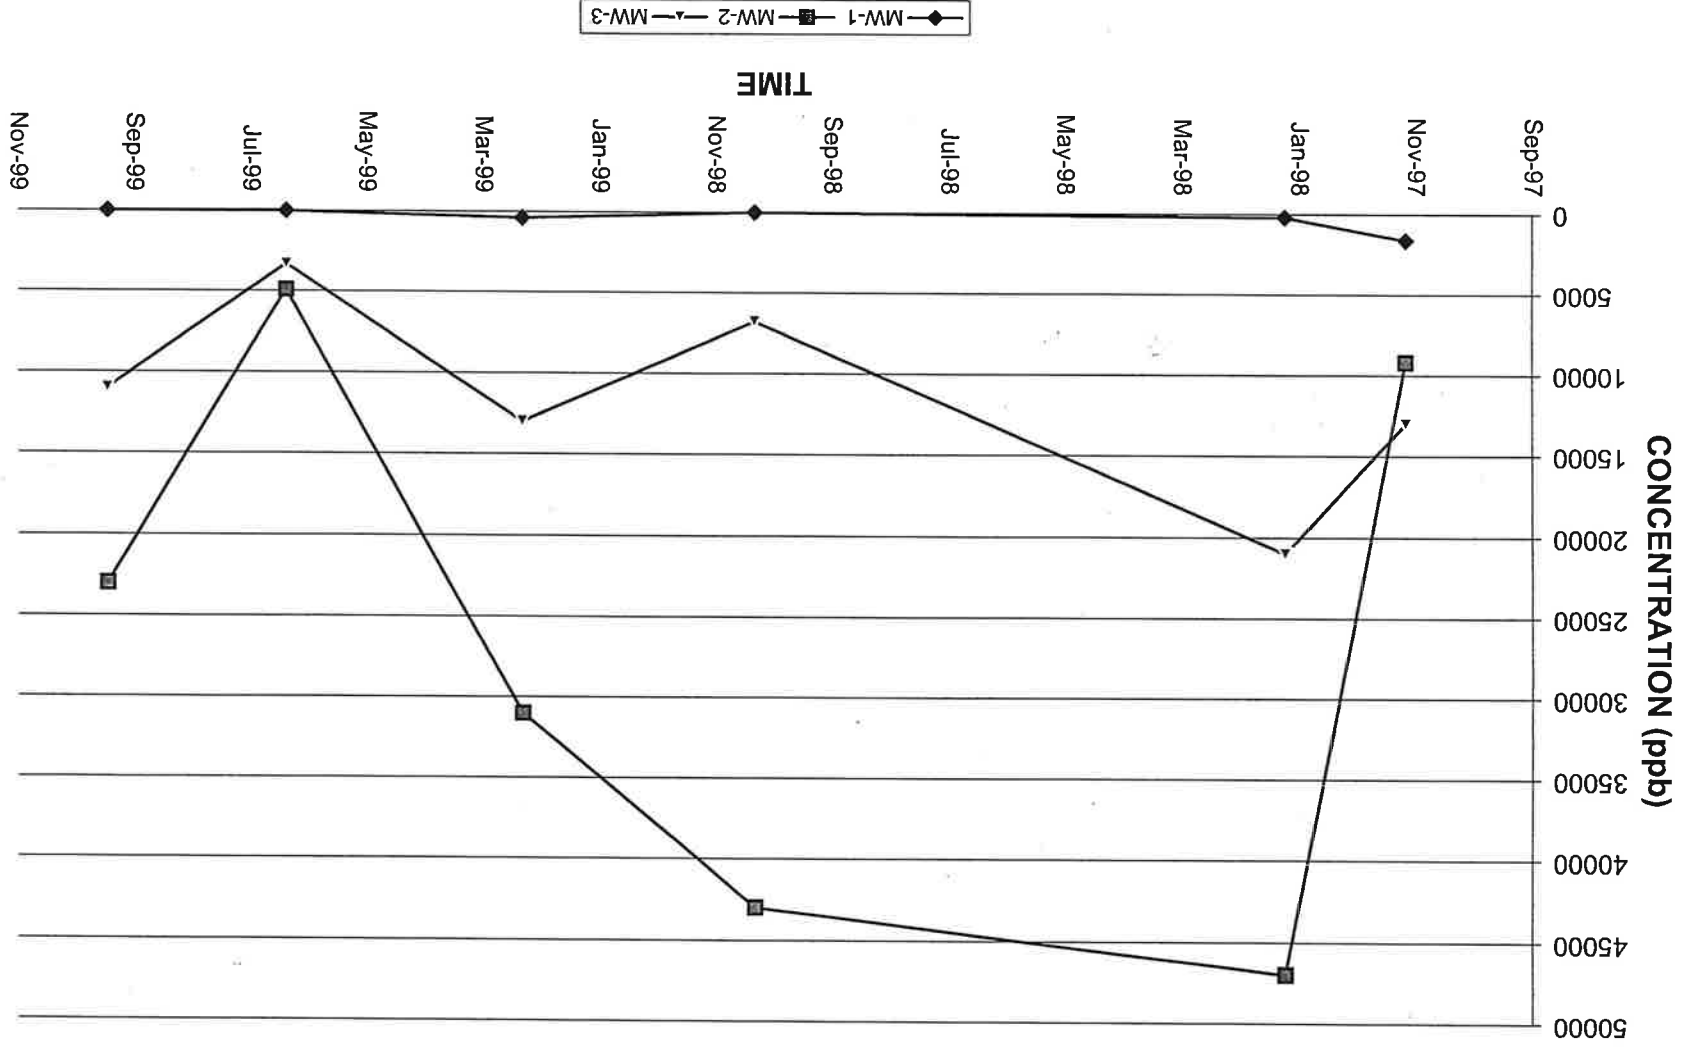
Figure 3: GRO Concentrations vs. Time

Petroleum levels in the groundwater continue to fluctuate, possibly the result of changes in groundwater elevations. GRO, DRO and VOC constituents continue to be above MPCA action levels or MDH HRLs. Groundwater flow has been consistently south-southeasterly. Our push-probes completed off-site in February 17, 1998 (in the inferred downgradient direction) indicate no significant petroleum detections at that time. Additionally, the bioactivity indicator parameters indicated that natural biodegradation was occurring.

To establish plume stability, we recommend that one downgradient monitoring well be installed and the four wells be sampled an additional four quarters, to establish that contaminant concentrations are below the HRLs for two consecutive monitoring events at the downgradient monitoring well, or a declining contamination concentration trend is documented with a minimum of three consecutive monitoring events. The groundwater samples would be analyzed for GRO, DRO and VOCs. We also recommend that a vapor survey be completed in the nearby utilities, based on the high contaminant concentrations in the groundwater.
