RE: RI/CAD, Union Co-op Oil, Hector, MN Leak #68

REMEDIAL INVESTIGATION REPORT WORKSHEET

R/CAD
FARMERS UNION OIL COOP PROPERTY
Hector, Minnesota
LEAK#00000068

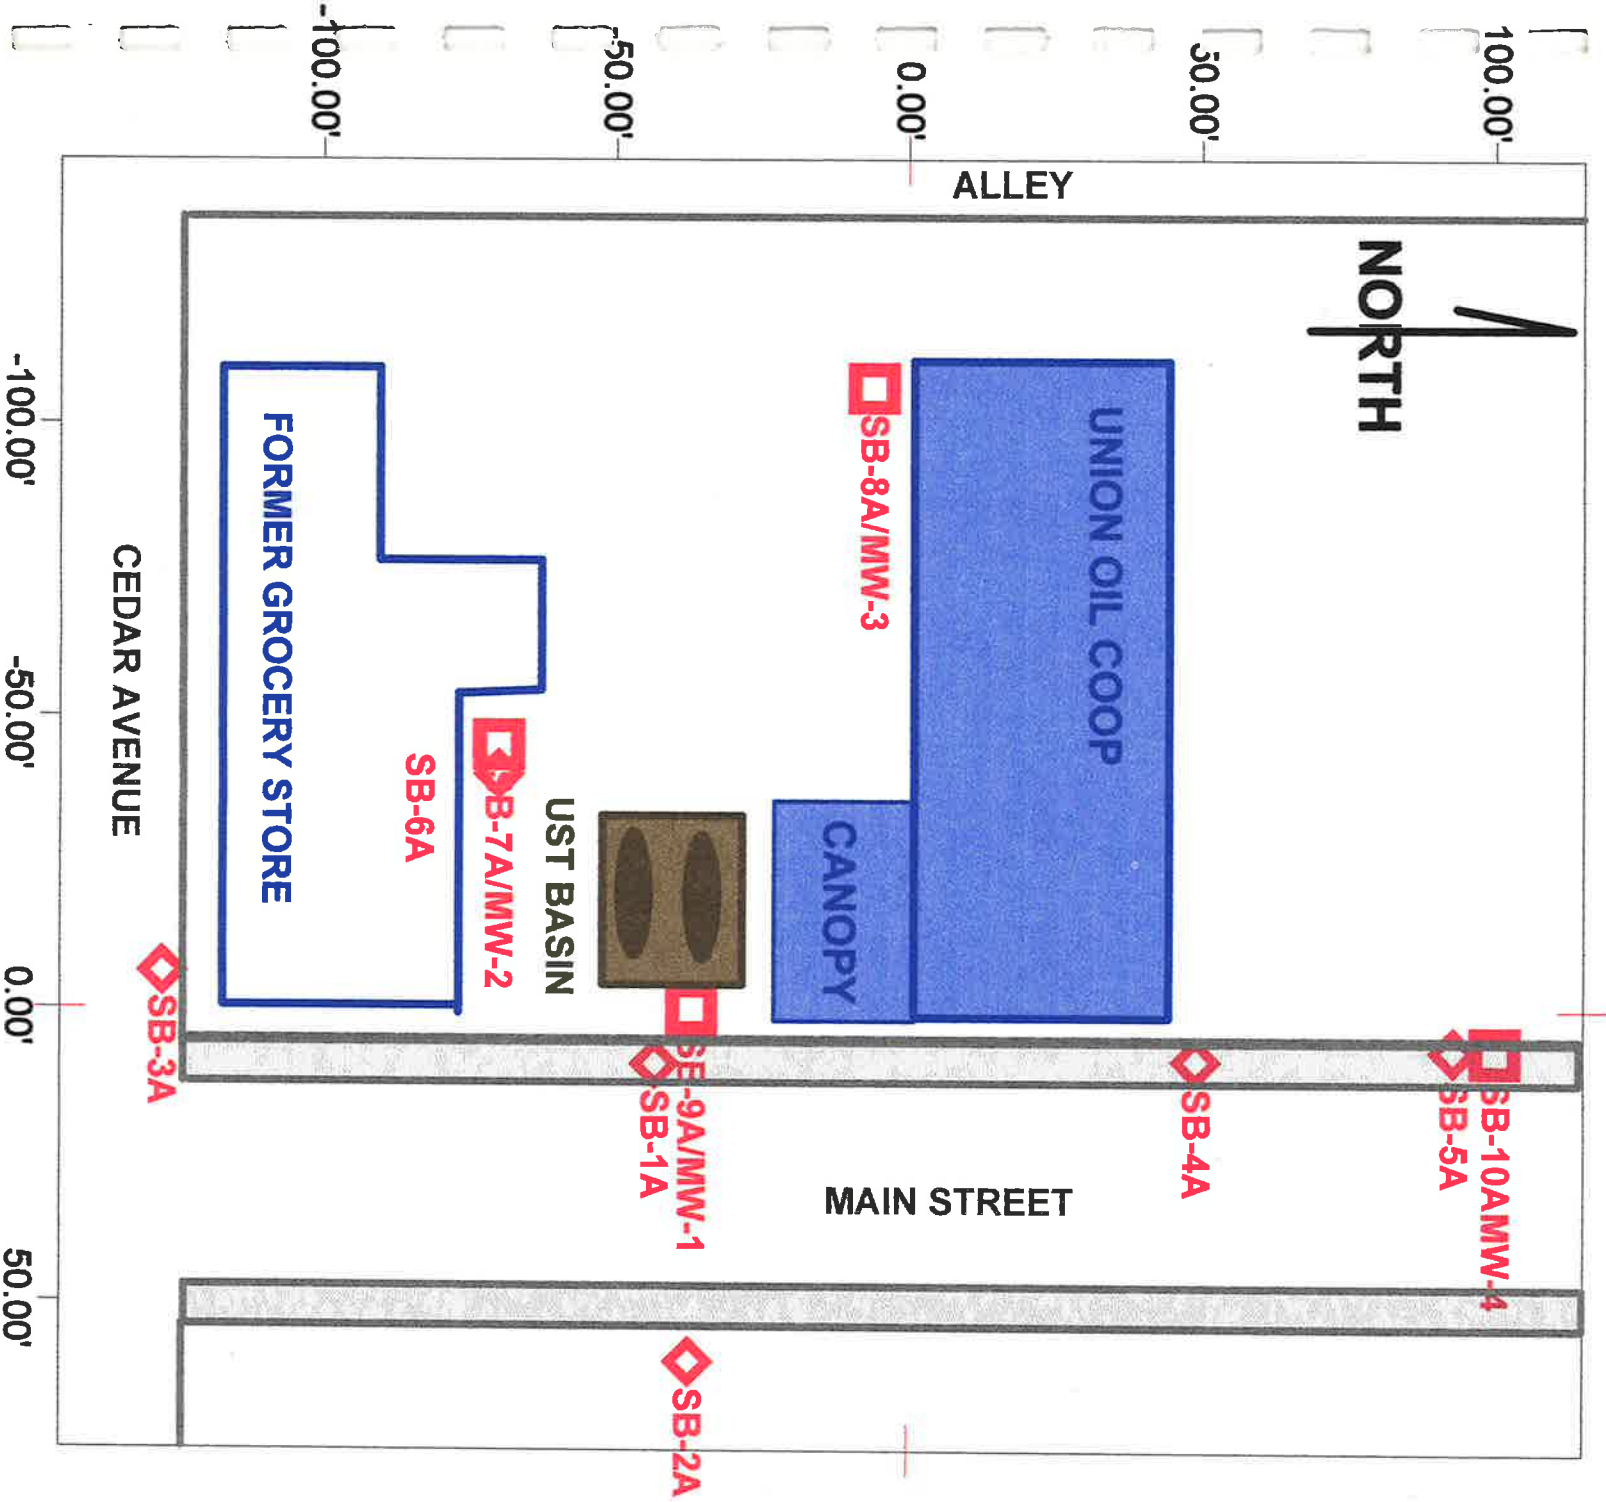
FIGURE 3 SITE MAP

Figure 3 illustrates the site (UST basin, soil borings and monitoring wells).
