April 26, 1996

RE: **Project Status**
Richfield Redevelopment Project
Richfield, MN
RE/SPEC Project #302-49.7

Site Diagram
Richfield Redevelopment
Richfield, Minnesota
RE/SPEC #302-049.1

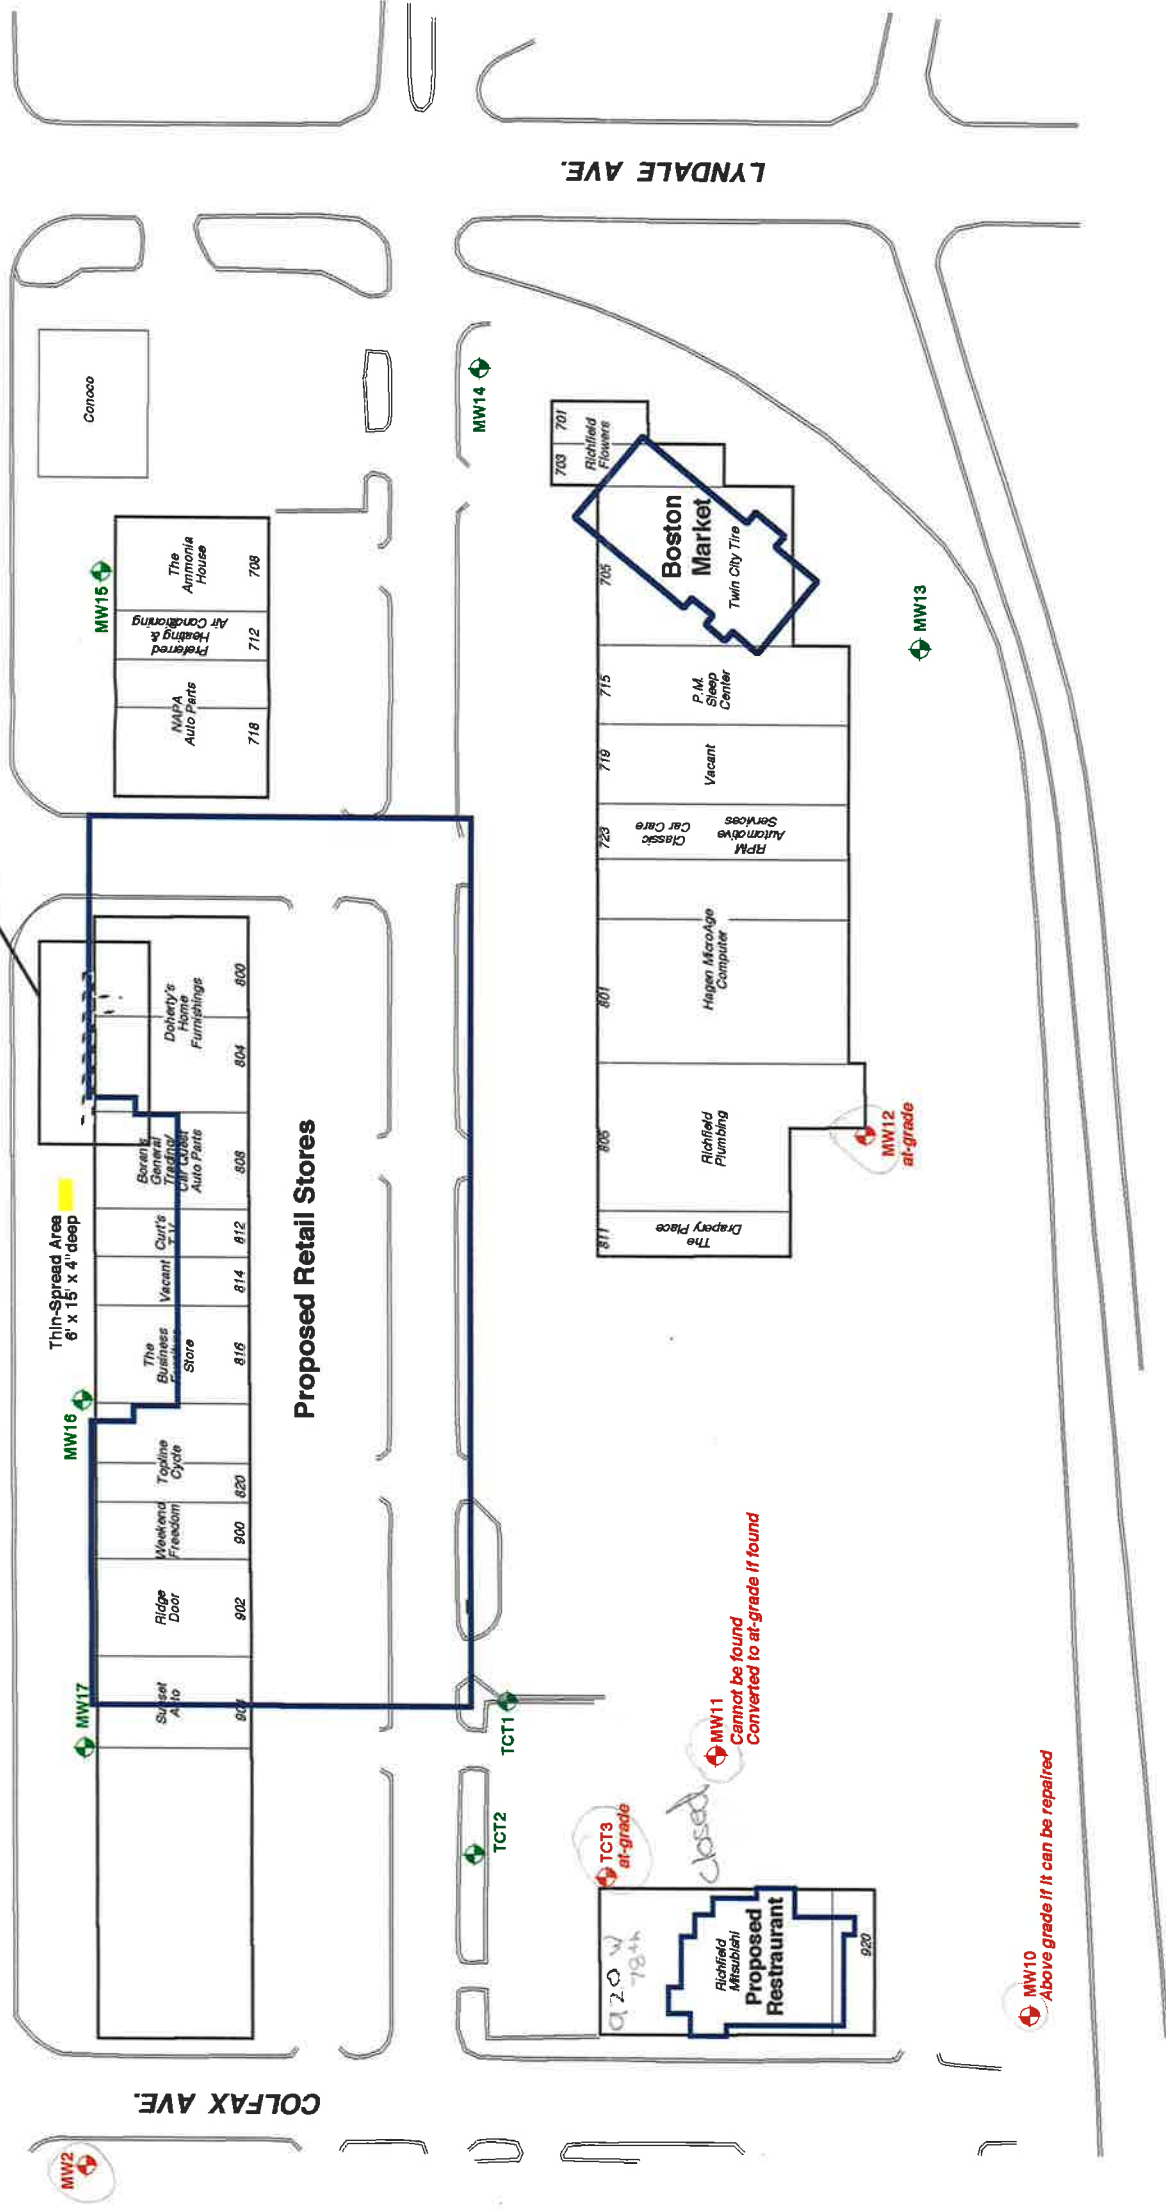
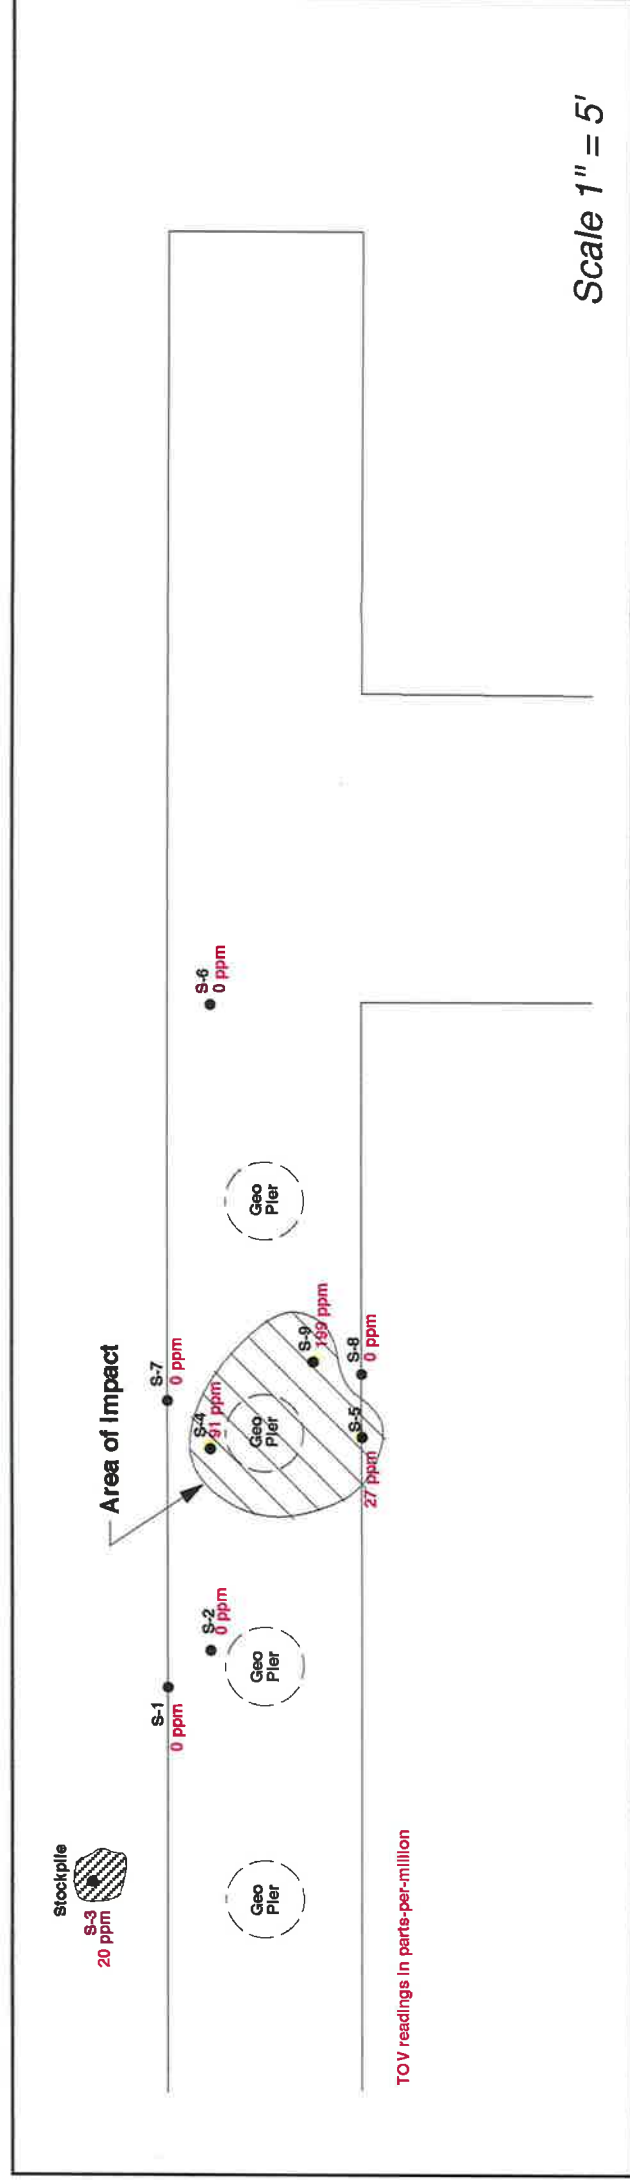
FIGURE 1

Field screening with a PID detected elevated total organic vapors (TOV) in a small area of stained soils encountered during footing excavation. These soils were not located in the area of the former dry cleaner and stained soils were not noted during Geo Pier installation. Approximately 1.5 cubic yards of stained soil were removed and stockpiled on site. See Figure 1 for sample locations and TOV readings. Further excavation of stained soils was limited due to the presence of the Geo Piers.

Stained soils appear limited to a depth interval of 1 to 5 feet below grade. Approximately 1.5 cubic yards of impacted soils were removed and impacts to remaining soils have been characterized. Due to the limited area of contamination and low levels of contaminants present, RE/SPEC requests MPCA approval to thinspread the stockpiled soils on-site in the area shown

on Figure 1 and MPCA closure of this leaksite. Any remaining soil impacts are covered by onsite structures such as buildings and pavement.
