**WETLAND DETERMINATION DATA FORM - North Central and Northeast Region**

Project/Site: L3R City/County: Clearwater Sampling Date: 2016-07-01

Applicant/Owner: Enbridge State: Minnesota Sampling Point: CL016a15W

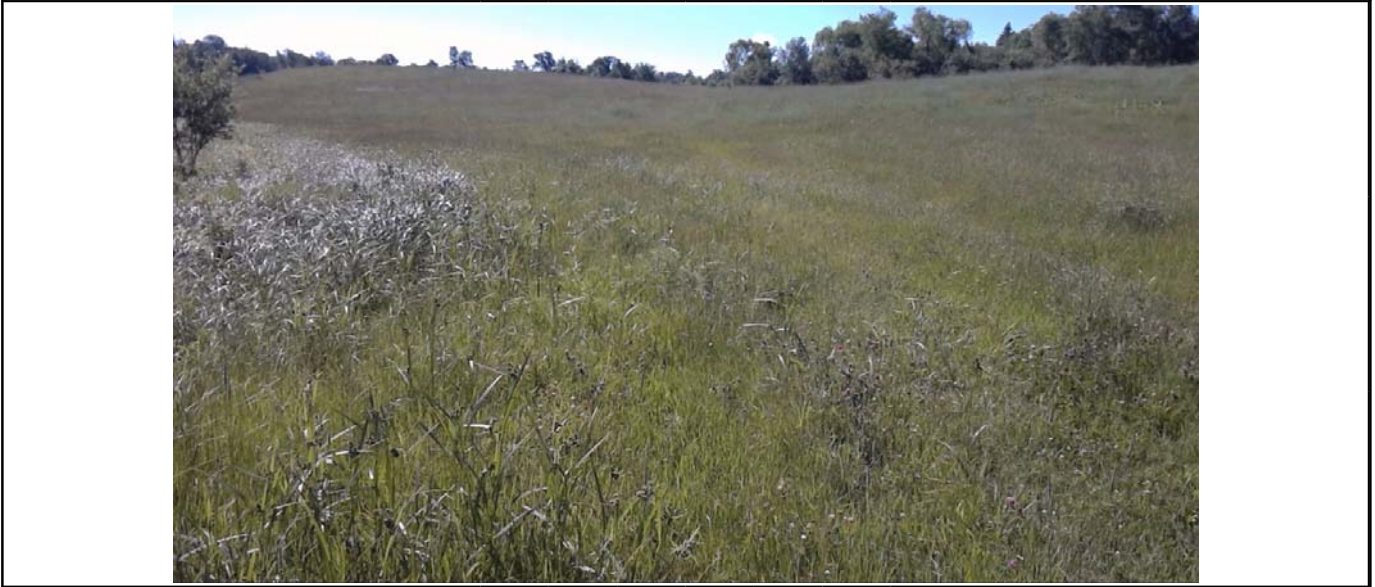
Site Photograph 1

Cowardin Classification: PEM

Direction: south

Eggers & Reed: Fresh (Wet) Meadow

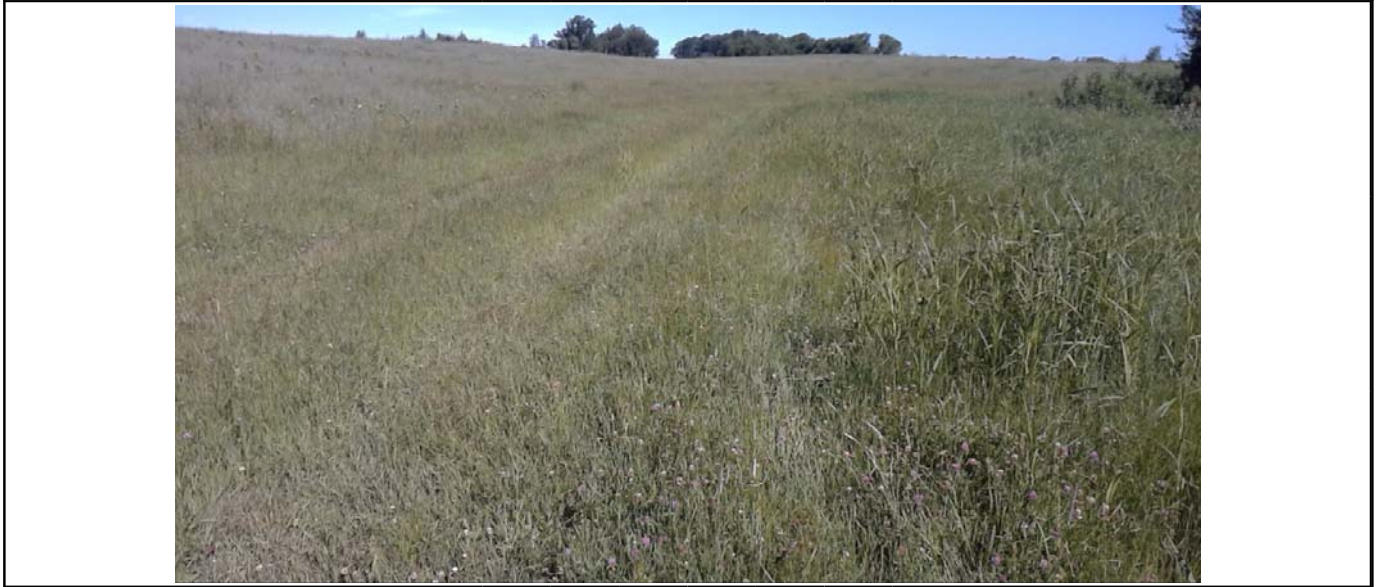
Site Photograph 2

Cowardin Classification: PEM

Direction: north

Eggers & Reed: Fresh (Wet) Meadow
