**WETLAND DETERMINATION DATA FORM - North Central and Northeast Region**

Project/Site: SPP City/County: Wadena Sampling Date: 2016-07-25  
 Applicant/Owner: Enbridge State: Minnesota Sampling Point: u-138n33w1-aa1  
 Investigator(s): DPT, MGH Section, Township, Range: S1, T138N, R33W  
 Landform (hillslope, terrace, etc.): Rise Local Relief (concave, convex, none): VL Slope (%): 0-2%  
 Subregion (LRR or MLRA): \_\_\_\_\_ Latitude: 46.7930752085... Longitude: -94.78910095... Datum: NAD83  
 Soil Map Unit Name: 564 NWI Classification: N/A  
 Are climatic/hydrologic conditions on the site typical for this time of year? (if no, explain in Remarks): No  
 Are Vegetation No, Soil No, or Hydrology No significantly disturbed? Are "Normal Circumstances" present? Yes  
 Are Vegetation No, Soil No, or Hydrology No naturally problematic? (If needed, explain any answers in Remarks)

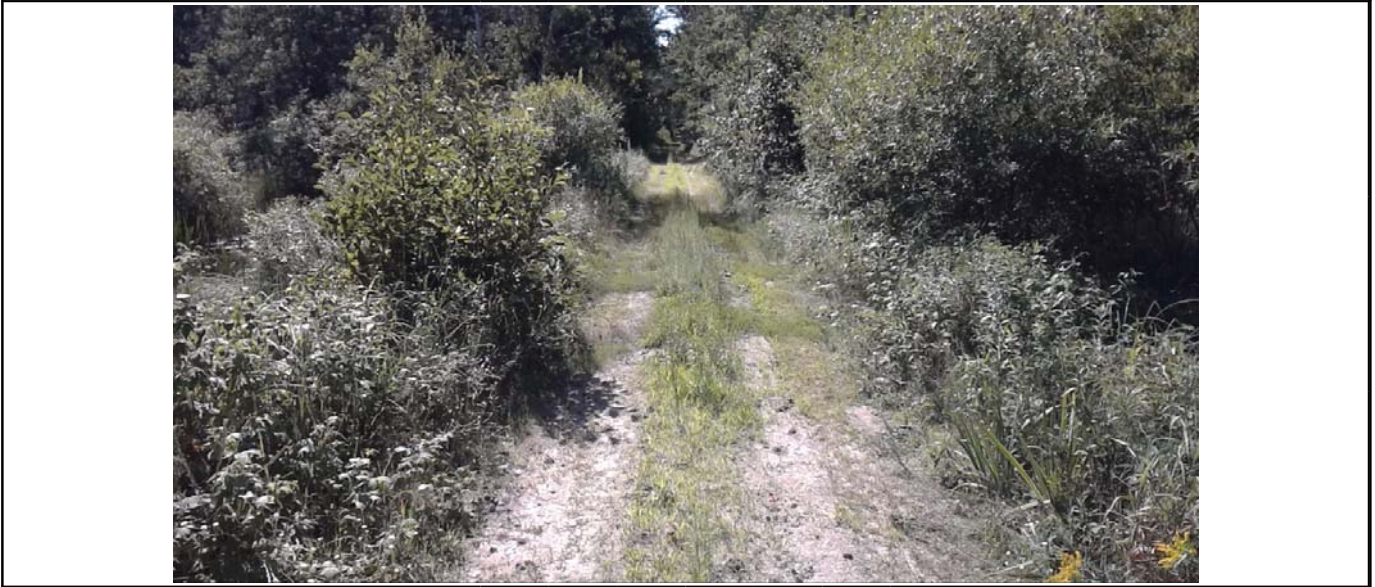
Site Photograph 1

Remarks:  
upland

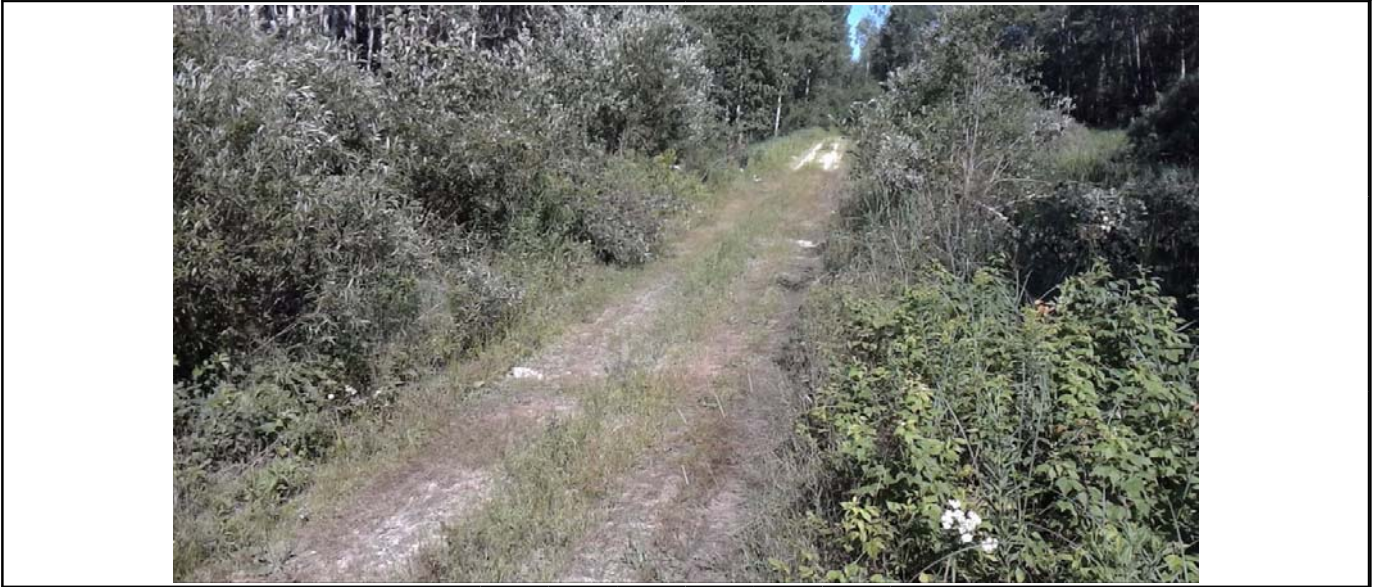
Site Photograph 2

Remarks:  
upland
