**WETLAND DETERMINATION DATA FORM - North Central and Northeast Region**

Project/Site: SPP City/County: Cass Sampling Date: 2016-08-02

Applicant/Owner: Enbridge State: Minnesota Sampling Point: u-139n25w18-aj1

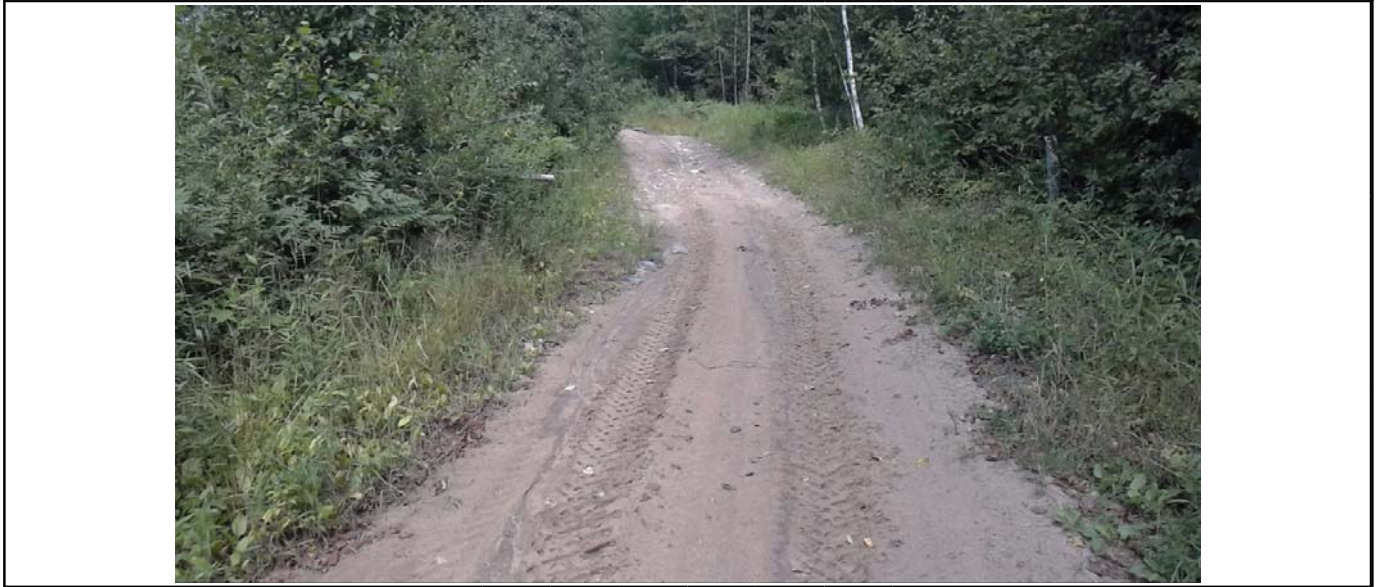
Site Photograph 1

Direction: north

Upland

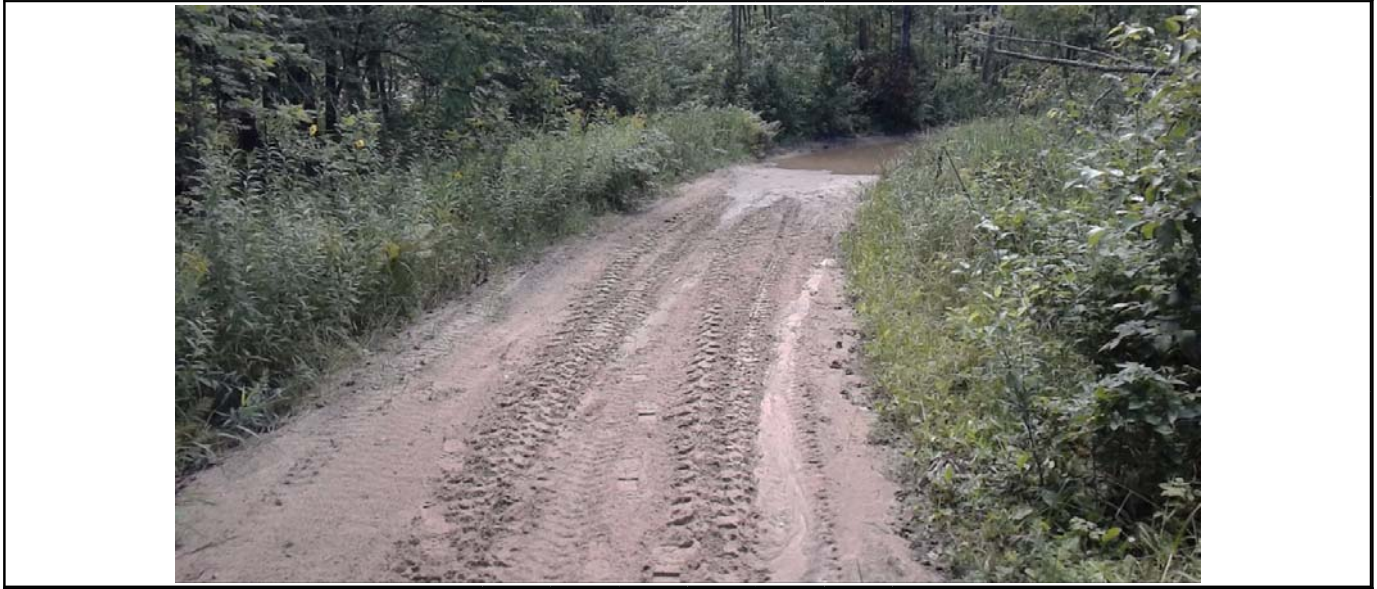
Direction: south

Upland
