WETLAND DETERMINATION DATA FORM - North Central and Northeast Region

Project/Site: SPP City/County: Carlton Sampling Date: 2016-09-06
 Applicant/Owner: Enbridge State: Minnesota Sampling Point: w-47n21w09-aa1
 Investigator(s): DPT, ZCW Section, Township, Range: T9, S47N, R21W
 Landform (hillslope, terrace, etc.): Depression Local Relief (concave, convex, none): CC Slope (%): 0-2%
 Subregion (LRR or MLRA): _____ Latitude: 46.5783507982... Longitude: -92.99555095... Datum: NAD83
 Soil Map Unit Name: 21C NWI Classification: N/A
 Are climatic/hydrologic conditions on the site typical for this time of year? (if no, explain in Remarks): No
 Are Vegetation No, Soil No, or Hydrology No significantly disturbed? Are "Normal Circumstances" present? Yes
 Are Vegetation No, Soil No, or Hydrology No naturally problematic? (If needed, explain any answers in Remarks)

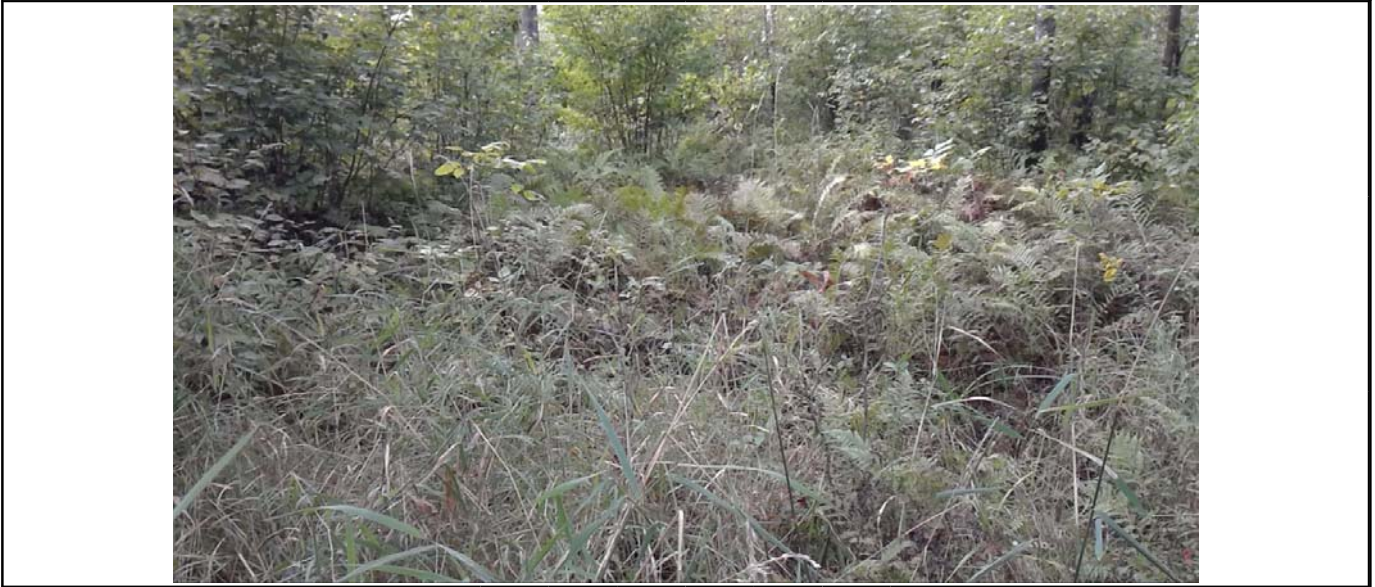
Site Photograph 1

Direction: west

Eggers & Reed: Seasonally Flooded Basin

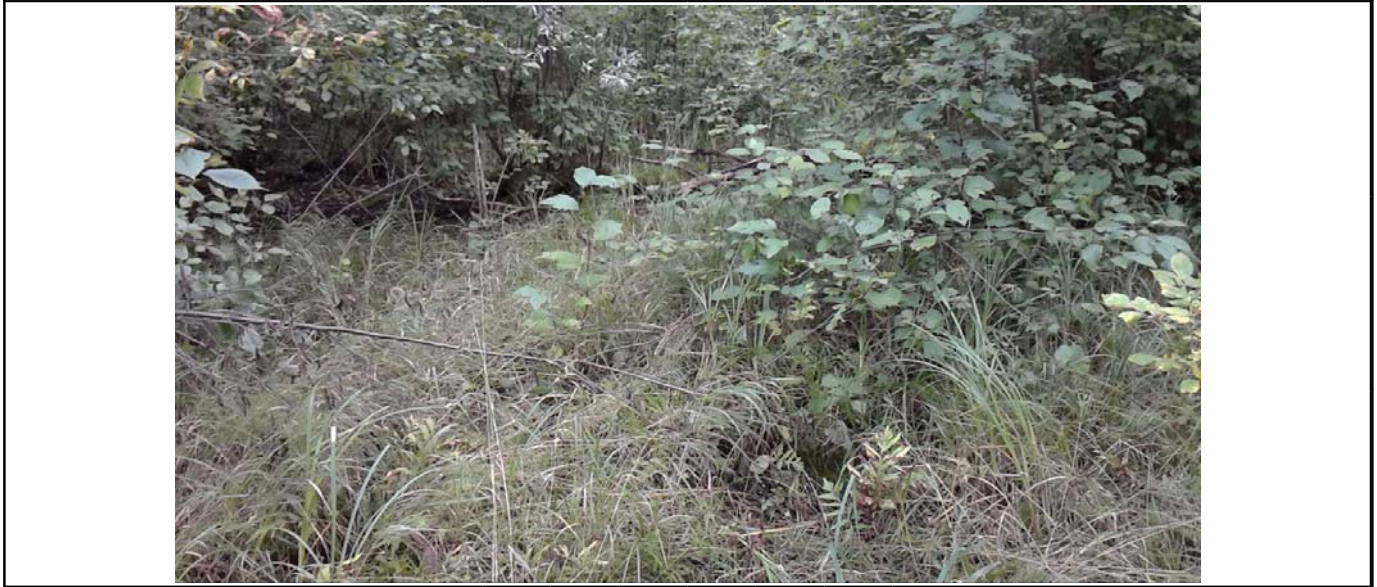
Site Photograph 2

Direction: east

Eggers & Reed: Seasonally Flooded Basin
