## WETLAND DETERMINATION DATA FORM - Great Plains Region

Project/Site: SPP City/County: Clearwater Sampling Date: 2016-07-28  
 Applicant/Owner: Enbridge State: Minnesota Sampling Point: CLC5040\_000RRa1W  
 Investigator(s): mts mew Section, Township, Range: \_\_\_\_\_  
 Landform (hillslope, terrace, etc.): Toeslope Local Relief (concave, convex, none): CC Slope (%): 3-7%  
 Latitude: 47.5293621188... Longitude: -95.37027262...

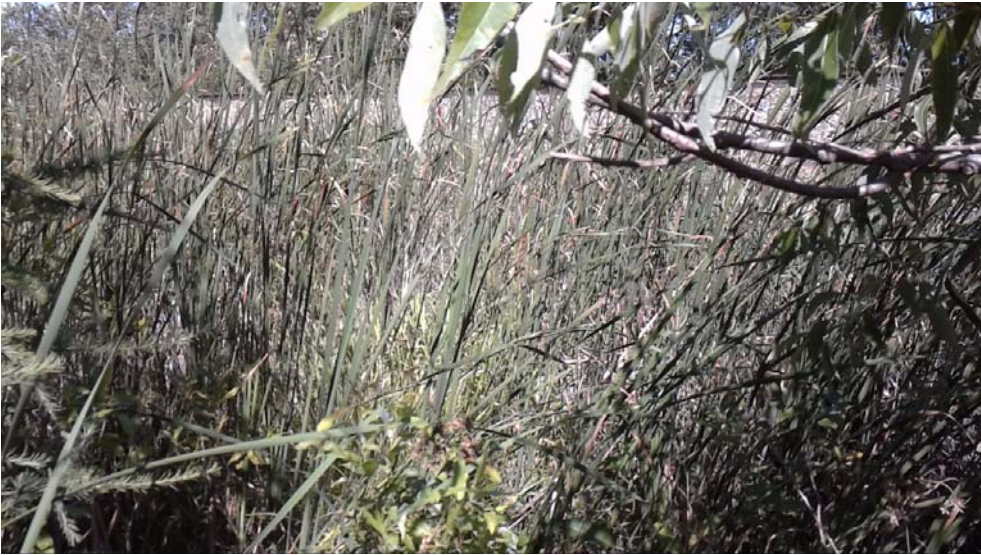
Latitude: 47.5293662259798  
Longitude: -95.3703053948426  
Direction: N

Cowardin Classification: PEM  
Circular 39: 2  
Eggers & Reed: Fresh (Wet) Meadow
