# WETLAND DETERMINATION DATA FORM - North Central and Northeast Region

Project/Site: SPP City/County: Aitkin Sampling Date: 2015-07-01  
 Applicant/Owner: Enbridge State: Minnesota Sampling Point: AI008b1W\_R  
 Investigator(s): ZSW/DAL Section, Township, Range: 26, 51n, 27w  
 Landform (hillslope, terrace, etc.): Depression Local Relief (concave, convex, none): Concave Slope (%): 0  
 Subregion (LRR or MLRA): LRR K Latitude: 46.8714911397... Longitude: -93.73143847... Datum: Minnesota State ...  
 Soil Map Unit Name: 142 NWI Classification: \_\_\_\_\_

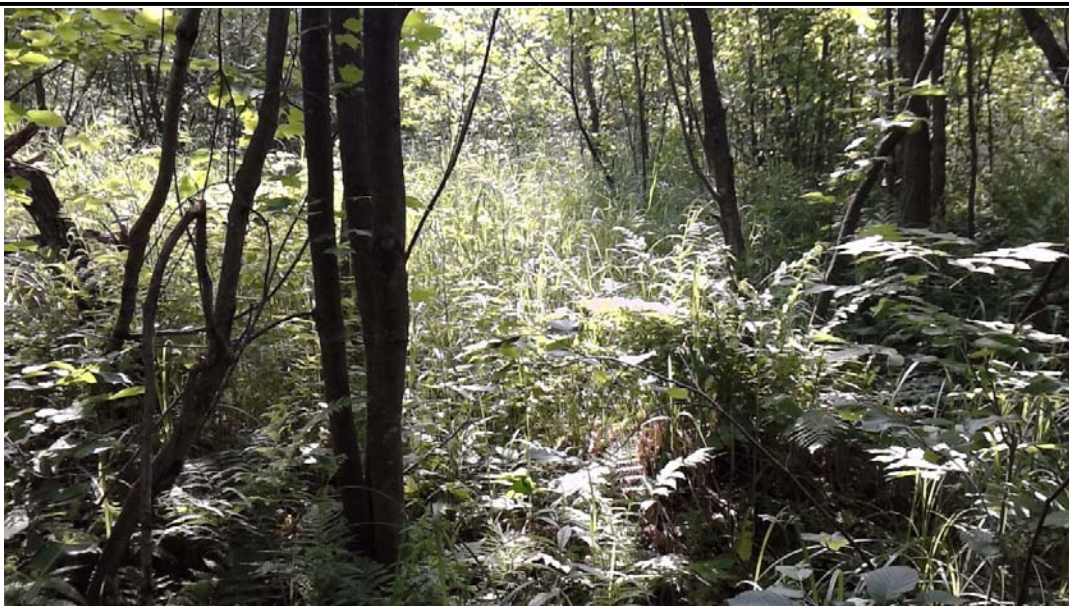
Latitude: 46.8714899663319Cowardin Classification: PFOLongitude: -93.7314372138062Circular 39: 7Direction: EastEggers & Reed: Hardwood Swamp/Coniferous Swamp
