# WETLAND DETERMINATION DATA FORM - North Central and Northeast Region

Project/Site: SPP City/County: Aitkin Sampling Date: 2015-07-10  
 Applicant/Owner: Enbridge State: Minnesota Sampling Point: AI114a1U\_R  
 Investigator(s): ZSW/DPT Section, Township, Range: 26, 49n, 25w  
 Landform (hillslope, terrace, etc.): Road Shoulder Local Relief (concave, convex, none): Concave Slope (%): 0  
 Subregion (LRR or MLRA): LRR K Latitude: 46.6977575049... Longitude: -93.46897199... Datum: Minnesota State ...  
 Soil Map Unit Name: 1878 NWI Classification: PSS/EM5B

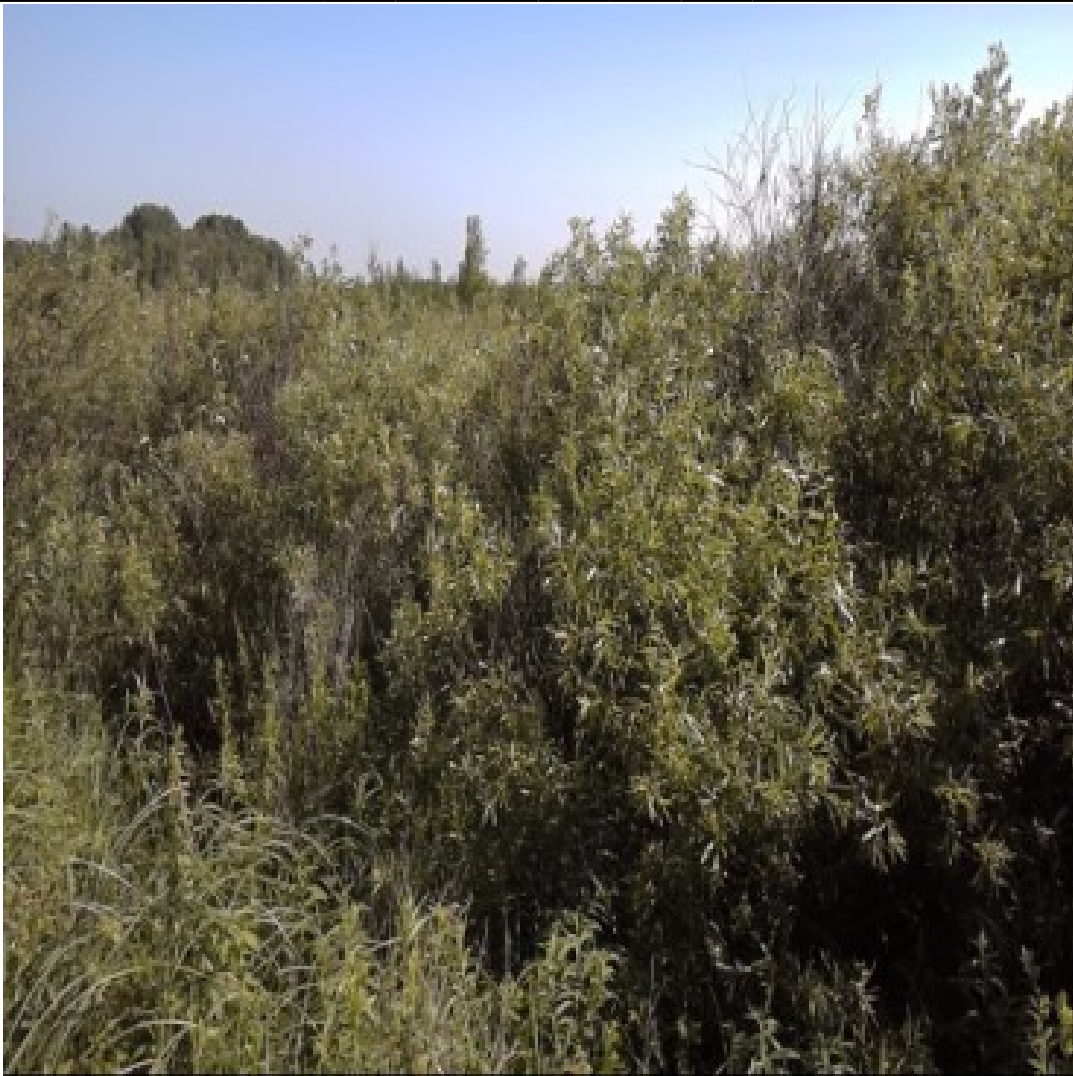
Direction: East

| Hydric Soil Indicators: | | Indicators for Problematic Hydric Soil <sup>3</sup> : |
|---|---|---|
| no soils road shoulder | | |
