L3R	D DETERMINATI Marshal		RM - Great Pl	-	2015-06-08
Project/Site: City Enbridge	//County:	Min	nesota	Sampling Date:	u-157n47w26-b1
Applicant/Owner:BCS/LEB		State:		Sampling Point: 5 T157N R26W	
Investigator(s):	S	ection, Towns			
Talf Landform (hillslope, terrace, etc.):		Local Relief	(concave, con	LL vex, none):	0-2 Slope (%):
LRR F Subregion (LRR or MLRA):	Latitude:	48.386749592	6 Longi	-96.69053879 ude:	
Minnesota State Plane North, NAD 83					
Datum: 170A					PEMAd
Soil Map Unit Name:				NWI Classificatio	on: Yes
Are climatic/hydrologic conditions on the site typical					
Are Vegetation No, Soil No, or Hydrology No	_ significantly dist	turbed? Are "I	Normal Circums	tances" present?	
Are Vegetation, Soil, or Hydrology	naturally problem	atic? (If need	ed, explain any	answers in Remarks)	
SUMMARY OF FINDINGS - Attach site map showi		t locations, tra	nsects, importa	ant features, etc.	
lydrophytic Vegetation Present?		Is the Sam	pled Area

emarks:									
Soil saturated to	o the surface due to i	recent he	eavy rains, but no ot	her wetland	d hydrol	ogy indi	cators observed	d.	
US Army Corps of	Engineers							Northcentral and Northea	ast Region – Version 2.0
ite Photograph	1

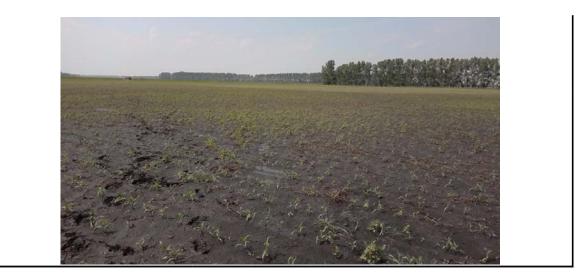
Hydric Soil Present?	lo	within a W	etland?	No	-
Y Wetland Hydrology Present?	es	If yes, optio	onal Wetland Si	te ID:	
Remarks: (Explain alternative procedures here or in	a separate report.	.)			
Upland sample area is located within a flat, tilled co	rn field. The area v	was previously	mapped as an	NWI, but does not pass hydric	soil or hydrophytic ve
VEGETATION - Use scientific names of plants.				1	
	Absolute % Cover	Dominant	Indicator	Dominance Test worksheet:	
Tree Stratum (Plot Size:)		Species?	Status	Number of Dominant Species That Are OBL, FACW, or FAC: 0	(A)

Latitude: 48.3867408754755	Cowardin Classification:					
Longitude: -96.6905126442171	Circular 39:					
Direction: NE	Eggers & Reed:					
Remarks:						
Upland NWI						
US Army Corps of Engineers	Northcentral and Northeast Region – Version 2.0					
Site Photograph 2	Sampling Point: u-157n47w26-b1
