WETLAND DETERMINATION DATA FORM - Great Plains Region

Project/Site: SPP Ci	ty/County: Polk			Sampling Date: 2010	6-06-29
Applicant/Owner: Enbridge		State: Mir	nesota	Sampling Point: u-15	50n45w18-ab1
Investigator(s): DPT, ZCW		Section, Towns	hip, Range: S1	 8, T150N, R45W	
Landform (hillslope, terrace, etc.): Side Slope			ef (concave, con		pe (%): 3-7%
Latitude: 47.8038665140	Longitude	-96.47859038		. ,	
			_		
Datum: NAD83					
Soil Map Unit Name: 129D				NWI Classification: NWI	I/A
Are climatic/hydrologic conditions on the site typica	al for this time of	year? (if no, exp	olain in Remarks	s): Yes	·
Are Vegetation No , Soil No , or Hydrology No	o significantly di	isturbed? Are "	Normal Circum	stances" present? Yes	
Are Vegetation No , Soil No , or Hydrology No	_ naturally proble	matic? (If need	ded, explain any	y answers in Remarks)	
SUMMARY OF FINDINGS - Attach site map show	ving sampling poi	nt locations, tra	nsects, import	ant features, etc.	
Hydrophytic Vegetation Present?	No Is the Sampled Area				<u>—</u> ———

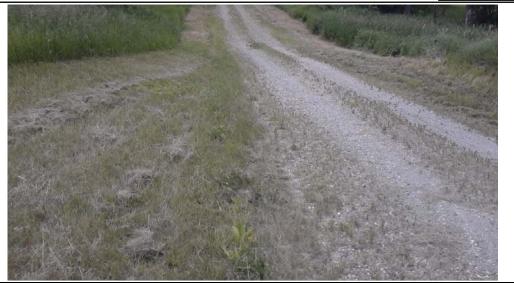
Latitude:	47.8038663045017
-----------	------------------

Longitude: -96.4785922319596

Direction: west

Remarks: upland

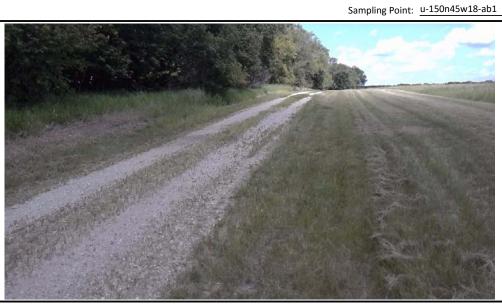
Site Photograph 2

Latitude: 47.8038673522396

Longitude: <u>-96.478590304</u>1218

Direction: east

Remarks: upland
