WETLAND DETERMINATION DATA FORM - Great Plains Region

Project/Site: SPP	City/Cour	nty: Polk			Sampling I	Date: 2016-06-29	
Applicant/Owner: Enbridge			State: Min	inesota	Sampling F	Point: u-150n48w5-aa1	
Investigator(s): DPT, ZCW		Se	ction, Towns	hip, Range: S5,	T150N, R48W		
Landform (hillslope, terrace, etc.): Side Slope				f (concave, con		Slope (%): 3-7%	
Latitude: 47.8407887137	14	 ongitude: -96					
Editidue.		ongitude. <u></u>		-			
Datum: NAD83							
Soil Map Unit Name: 149A					NWI Classif	ication: N/A	
Are climatic/hydrologic conditions on the site t	typical for th	is time of yea	r? (if no, exp	lain in Remarks	s):	Yes	
Are Vegetation No, Soil No, or Hydrolog	gy <u>No</u> sign	ificantly distu	irbed? Are "	Normal Circums	stances" present? Yes		
Are Vegetation No_, Soil No_, or Hydrology	No natur	ally problema	tic? (If need	led evolain anv	answers in Remarks)		
, the regetation, som, or rivations,		any problema	tie. (ii lieee	ica, explain any	unswers in Remarks,

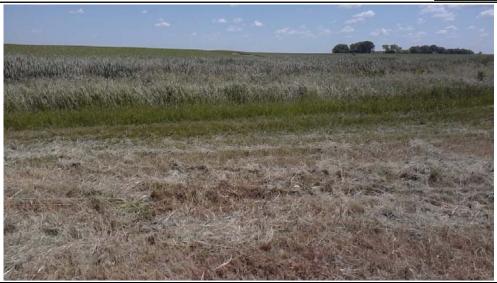
Latituda	47.8408063156976

Longitude: -96.8262858130939

Direction: east

Remarks: upland

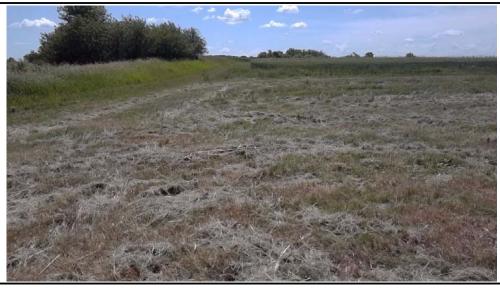
Site Photograph 2 Sampling Point: u-150n48w5-aa1

Latitude: 47.8408085369019

Longitude: -96.8262929377116

Direction: south

Remarks: upland
