WETLAND DETERMINATION DATA FORM - Great Plains Region

Project/Site: SPP	City/County: Polk			Sampling Date: 2016-06-29		
Applicant/Owner: Enbridge		State: Mir	nnesota	Sampling Point: w-150n45w18-aa1		
Investigator(s): DPT, ZCW		Section, Towns	ship, Range: S1	8, T150N, R45W		
Landform (hillslope, terrace, etc.): Depression			ef (concave, con			
Latitude: 47.8041027579	Longitude:	-96.47411570		· ——		
	· ·		_			
Datum: NAD83						
Soil Map Unit Name: 149A				NWI Classification: N/A		
Are climatic/hydrologic conditions on the site typ	ical for this time of	year? (if no, exp	olain in Remarks	s): Yes		
Are Vegetation No , Soil No , or Hydrology	No significantly d	listurbed? Are "	Normal Circum	stances" present? Yes		
Are Vegetation No_, Soil No_, or Hydrology No	o naturally proble	ematic? (If need	ded, explain any	y answers in Remarks)		
SUMMARY OF FINDINGS - Attach site map sho	owing campling no	int locations tr	ncocts import	cant features, etc.		
	Yes		pled Area	ant reatures, etc.

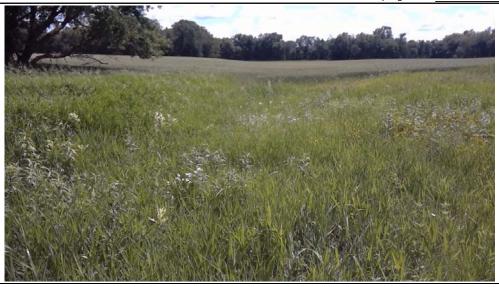
Latitude: 47.8040807974039

Longitude: -96.4741552715157

Direction: south

Cowardin Classification: PEM

Circular 39: 2

Eggers & Reed: Fresh (Wet) Meadow

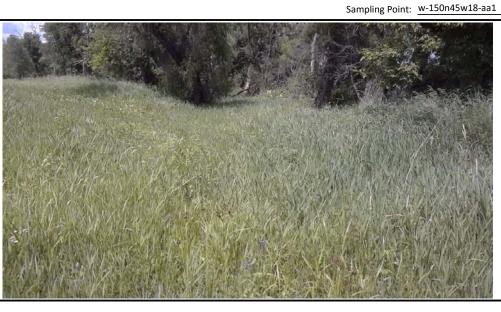
Site Photograph 2

Latitude: 47.8040810907705

Longitude: -96.4741546009634

Direction: north

Cowardin Classification: PEM

Circular 39: 2

Eggers & Reed: Fresh (Wet) Meadow
