WETLAND DETERMINATION DATA FORM - Great Plains Region

Project/Site: SPP	City/County: Polk			Sampling Date: 2016-06-29				
Applicant/Owner: Enbridge		State: Mi	nnesota	Sampling Point: w-150n45w18-	-ab2			
Investigator(s): DPT, ZCW		Section, Town	ship, Range: S1	8, T150N, R45W				
Landform (hillslope, terrace, etc.): Depression			ef (concave, con		<u></u> %			
Latitude: 47.8038746025	Longitude:	-96.47954047		· · · · · · · · · · · · · · · · · · ·				
·	J		_					
Datum: NAD83								
Soil Map Unit Name: 149A				NWI Classification: N/A				
Are climatic/hydrologic conditions on the site ty	pical for this time of	year? (if no, ex	plain in Remarks	s): Yes	_			
Are Vegetation No, Soil No, or Hydrology	No significantly d	listurbed? Are '	'Normal Circum	stances" present? Yes				
Are Vegetation No, Soil No, or Hydrology	No naturally proble	ematic? (If nee	ded, explain any	answers in Remarks)				
SUMMARY OF FINDINGS - Attach site map si	howing sampling po	int locations, tr	ansects, import	ant features, etc.

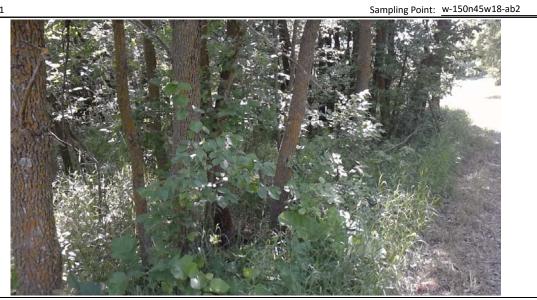
Latitude: 47.8038750635905

Longitude: -96.4795372915421

Direction: west

Cowardin Classification: PFO

Circular 39: 7

Eggers & Reed: Hardwood Swamp/Coniferous Swamp

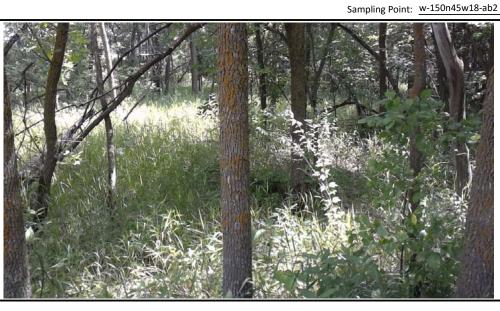
Site Photograph 2

Latitude: 47.8038750635905

Longitude: <u>-96.47953704</u>0085

Direction: south

Cowardin Classification: PFO

Circular 39: 7

Eggers & Reed: Hardwood Swamp/Coniferous Swamp
