WETLAND DETERMINATION DATA FORM - North Central and Northeast Region

Project/Site: SPP	Ci	City/County: Clearwater		Samplin	g Date: 2016-07-21
Applicant/Owner: Enbridge			State: Minnesota	Samplin	g Point: u-144n36w24-ac1
Investigator(s): ZCW		Section, Townshi	p, Range: S 24, T 144N, R	36W	
Landform (hillslope, terrace, etc.): Should	er		Local Relief (concave, co		Slope (%): 0-2%
Subregion (LRR or MLRA):		 Latitude: 47	•	gitude: -95.18452906	Datum: NAD83
Soil Map Unit Name: 267B				- <u> </u>	sification: N/A
Are climatic/hydrologic conditions on the	site tynic	al for this time of year	? (if no explain in Remark		Yes
		·			
Are Vegetation No , Soil No , or Hyd	Irology No	significantly disturk	ped? Are "Normal Circum	nstances" present? Yes	
Are Vegetation No_, Soil No_, or Hydro	ology <u>No</u>	naturally problemation	c? (If needed, explain an	y answers in Remarks)	
SUMMARY OF FINDINGS - Attach site	map shov	ving sampling point lo	cations, transects, impor	rtant features, etc.

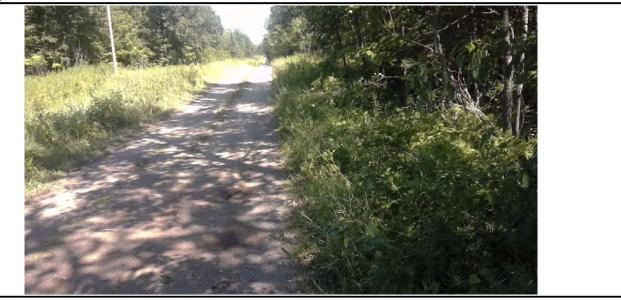
Site Photograph 1 Sampling Point: u-144n36w24-ac1

Latitude:	47.28261766494	Cowardin Classification:
Longitude:	-95.1845491771541	Circular 39:
Direction: East	<u> </u>	Eggers & Reed:
Remarks:

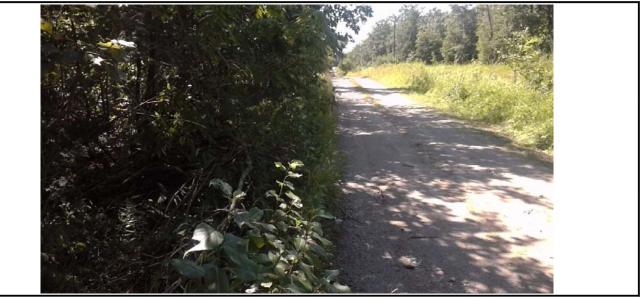
Site Photograph 2 Sampling Point: u-144n36w24-ac1

Latitude:	47.2826178744876		Cowardin Classification	
Longitude:	-95.1845484227829		Circular 39:	
Direction: Wes	st	_	Eggers & Reed:	
Remarks:
