## WETLAND DETERMINATION DATA FORM - North Central and Northeast Region

Project/Site: SPP	City/C	City/County: Clearwater			Sampling Date: 2016-06-30		
Applicant/Owner: Enbridge			State: Minnesota		Sampling Point: u-146r	136w31-NWI1	
Investigator(s): DPT, ZCW		Section, Townshi	p, Range: S31, T146	5N, R36W			
Landform (hillslope, terrace, etc.):	Rise		Local Relief (conca	ve, convex, none): VV	Slope	(%): 0-2%	
Subregion (LRR or MLRA):		 Latitude: 47	7.4233277328	Longitude: -95.29040	—— 0607	.D83	
Soil Map Unit Name: 125				N	IWI Classification: PSS:	ıc	
Are climatic/hydrologic conditions	on the site typical fo	r this time of year	? (if no, explain in R		Yes		
Are Vegetation No , Soil No ,	or Hydrology No s	ignificantly disturb	ned? Are "Normal C	Circumstances" present	? Yes		
Are Vegetation No_, Soil No_, o					· <u></u>		
SUMMARY OF FINDINGS - Atta	ch site map showing	sampling point lo	cations, transects,	important features, et	c.		
Hydrophytic Vegetation Present?	No		Is the Sampled Are	ea

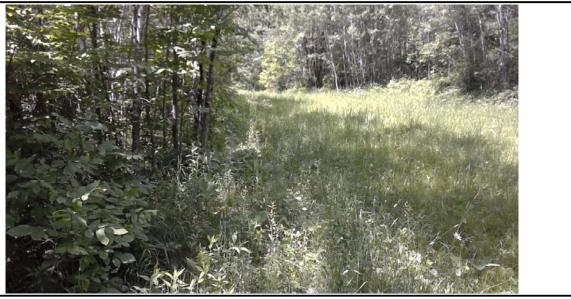
Site Photograph 1 Sampling Point: u-146n36w31-NWI1

Latitude: 47.4232982285762	Cowardin Classification:			
Longitude: -95.2904206608378	Circular 39:			
Direction: north	Eggers & Reed:			
Remarks:				
upland

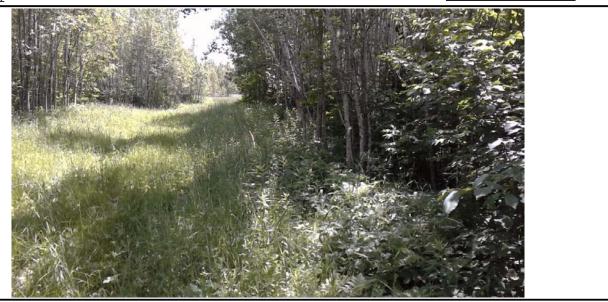
Site Photograph 2 Sampling Point: u-146n36w31-NWI1

Latitude:	47.4232982704858	Cowardin Classification:	
Longitude:	-95.2904207446569	Circular 39:	
Direction: sout	th	Eggers & Reed:	
Remarks:			
upland			
ı
