## WETLAND DETERMINATION DATA FORM - North Central and Northeast Region

Project/Site: SPP	City/County: C	City/County: Clearwater		Sampling Date: 2016-06-30	
Applicant/Owner: Enbridge		State: Minnesota		ng Point: u-146n36w31-NWI2	
Investigator(s): DPT, ZCW	Section,	Township, Range: S31, T14	6N, R36W		
Landform (hillslope, terrace, etc.): Side S	lope	Local Relief (conca	ave, convex, none): VV	Slope (%): 0-2%	
Subregion (LRR or MLRA):	Lat	itude: 47.4230116932	Longitude: -95.28978791	Datum: NAD83	
Soil Map Unit Name: 40B			NWI Cla	ssification: PEMC	
Are climatic/hydrologic conditions on the site typical for this time of year? (if no, explain in				Yes	
Are Vegetation No , Soil No , or Hy	drology No significant	ly disturbed? Are "Normal	Circumstances" present? Yes		
Are Vegetation No , Soil No , or Hydi	ology No naturally pro	oblematic? (If needed, exp	lain any answers in Remarks)		
SUMMARY OF FINDINGS - Attach site	e map showing sampling	g point locations, transects,	important features, etc.

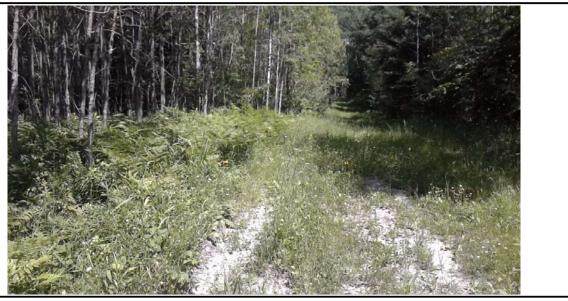
Site Photograph 1 Sampling Point: u-146n36w31-NWI2

Latitude:	47.4229300953889	Cowardin Classification:			
Longitude:	-95.2898134757721	Circular 39:			
Direction: east	t	Eggers & Reed:			
Remarks:					
upland

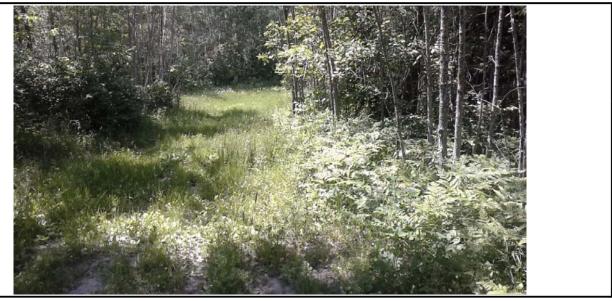
Site Photograph 2 Sampling Point: u-146n36w31-NWI2

Latitude:	47.4229300534794	Cowardin Classification:
Longitude:	: -95.2898134757721	Circular 39:
Direction: wes	st	Eggers & Reed:
Remarks:		
upland		
ĺ
