WETLAND DETERMINATION DATA FORM - North Central and Northeast Region

Project/Site: SPP	City/	City/County: Clearwater		Sampling Date: 2016-06-30		
Applicant/Owner: Enbridge			State: Minnesota	Sam	pling Point: u-146n36w32-NV	VI1
Investigator(s): DPT, ZCW		_ Section, Township	p, Range: <u>\$32,</u> T146N	N, R32W		
Landform (hillslope, terrace, etc.):	Side Slope		Local Relief (concave	e, convex, none): VV	Slope (%): 3-7%	
Subregion (LRR or MLRA):		 Latitude: 47	.4236259609	Longitude: -95.2839033	9 Datum: NAD83	
Soil Map Unit Name: 40B				NWI	Classification: PEMB	
Are climatic/hydrologic conditions	on the site typical f	for this time of year	? (if no, explain in Re	_	Yes	
Are Vegetation No , Soil No ,	or Hydrology NO	significantly disturb	ned? Are "Normal Ci	rcumstances" nresent? Y	es	
Are Vegetation No , Soil No , or						
SUMMARY OF FINDINGS - Attac				•		
Hydrophytic Vegetation Present?	No.		Is the Sampled Area	-		
Hydric Soil Present?	No		within a Wetland?	•	No	
Wetland Hydrology Present?	No		If yes, optional Wet	land Site ID:

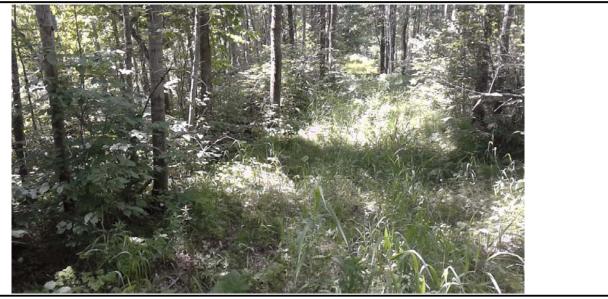
Site Photograph 1 Sampling Point: u-146n36w32-NWI1

Latitude:	47.4235428125108	Cowardin Classification:
Longitude:	-95.2838814352595	Circular 39:
Direction: wes	st	Eggers & Reed:
Remarks:		
upland		
1

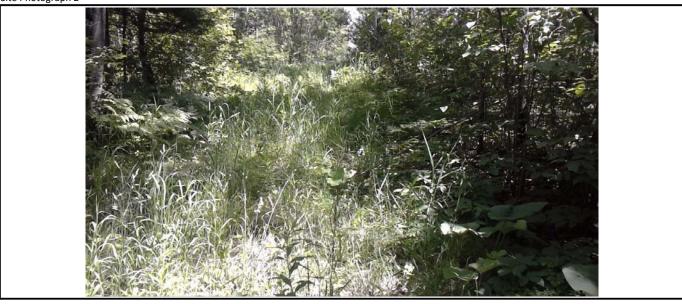
Site Photograph 2 Sampling Point: u-146n36w32-NWI1

Latitude: 47.4235729873622	Cowardin Classification:		
Longitude: -95.2839234285944	Circular 39:		
Direction: east	Eggers & Reed:		
Remarks:			
upland
