WETLAND DETERMINATION DATA FORM - North Central and Northeast Region

Site Photograph 1 Sampling Point: u-146n36w32-NWI2

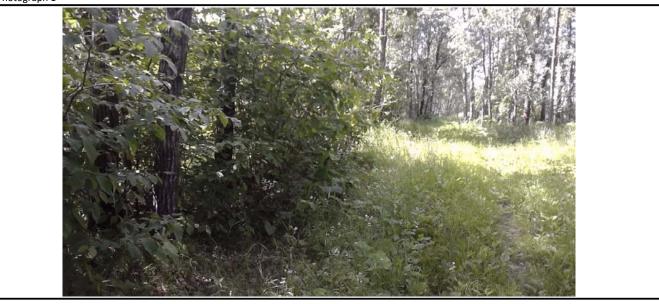
Latitude: 47.4244657019595	Cowardin Classification:
Longitude: -95.2841157932722	Circular 39:
Direction: north	Eggers & Reed:
Remarks:	
upland

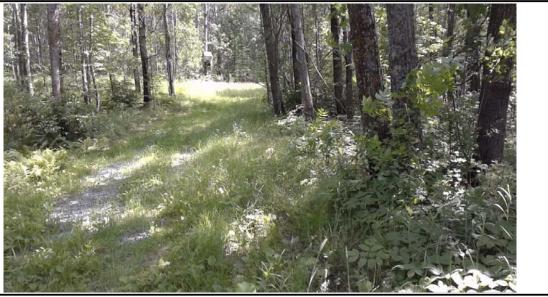
Site Photograph 2 Sampling Point: u-146n36w32-NWI2

Latitude:	47.4244662048737	Cowardin Classification:		
Longitude:	-95.2841160447293	Circular 39:		
Direction: sout	th	Eggers & Reed:		
Remarks:				
upland
