## WETLAND DETERMINATION DATA FORM - North Central and Northeast Region

Site Photograph 1 Sampling Point: u-146n36w32-ab1

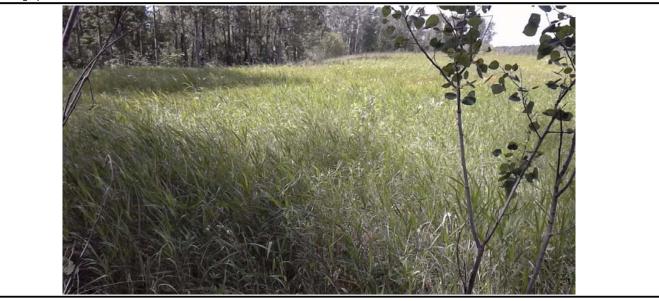
Latitude:	47.4248884851555	Cowardin Classification:
Longitude:	-95.2843621374064	Circular 39:
Direction: nor	th	Eggers & Reed:
Remarks:		
upland

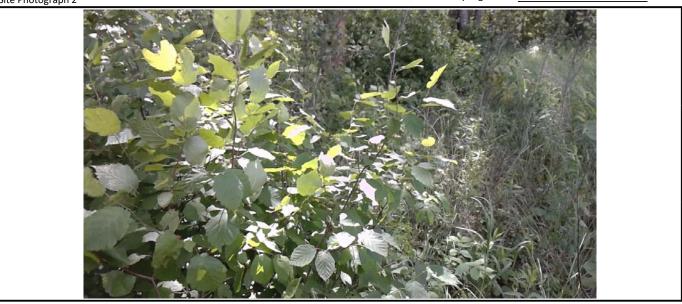
Site Photograph 2 Sampling Point: u-146n36w32-ab1

Latitude:	47.424897789068	Cowardin Classification:		
Longitude:	-95.2843634785109	Circular 39:		
Direction: wes	st	Eggers & Reed:		
Remarks:				
upland
