WETLAND DETERMINATION DATA FORM - North Central and Northeast Region

Project/Site: L3R	City/County: Cl	earwater	_ Sampl	Sampling Date: 2016-06-30		
Applicant/Owner: Enbridge		State: Minnesota		Sampling Point: u-149n37w29-a5		
Investigator(s): DPT, ZCW	Section,	Township, Range: S29, T14	9N, R37W			
Landform (hillslope, terrace, etc.): Ris	se	Local Relief (conca	ave, convex, none): VL	Slope (%): 0-2%		
Subregion (LRR or MLRA):	Lat	itude: 47.6924614236	Longitude: -95.41162901	Datum: NAD83		
Soil Map Unit Name: 582			NWI Cl	assification: N/A		
Are climatic/hydrologic conditions or	the site typical for this time	e of vear? (if no. explain in F		Yes		
Are Vegetation No , Soil No , or Hydrology No significantly disturbed? Are "Normal Circumstances" present? Yes						
Are Vegetation No , Soil No , or Hydrology No naturally problematic? (If needed, explain any answers in Remarks)						
SUMMARY OF FINDINGS - Attach	site map showing sampling	point locations, transects,	important features, etc.

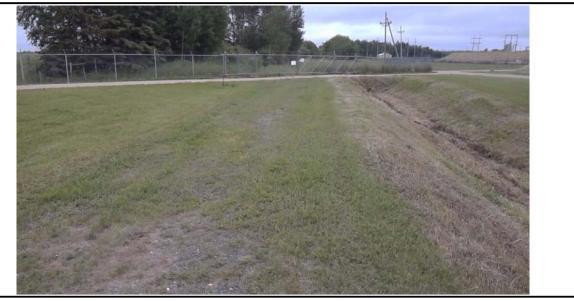
Site Photograph 1 Sampling Point: u-149n37w29-a5

Latitude:	47.6924590766874	Cowardin Classification:			
Longitude:	-95.411627339288	Circular 39:			
Direction: east		Eggers & Reed:			
Remarks:					
upland

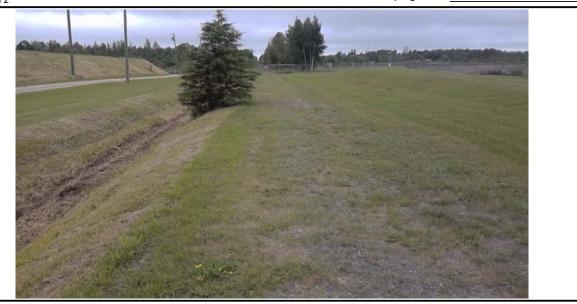
Site Photograph 2 Sampling Point: u-149n37w29-a5

A STATE OF THE PARTY OF THE PAR
Latitude: 47.6924483478513	Cowardin Classification:
Longitude: -95.411622058689	Circular 39:
Direction: west	Eggers & Reed:
Remarks:	
upland
