WETLAND DETERMINATION DATA FORM - North Central and Northeast Region

Project/Site: L3R	City/County: Clearwate	er	Sampling Date: 2016-06-20				
Applicant/Owner: Enbridge		State: Minnesota	Samplin	g Point: u-149n37w33-NWI			
Investigator(s): DPT, ZCW	Section, Townsh	ip, Range: <u>S33, T149N, R3</u>	7W				
Landform (hillslope, terrace, etc.): Side Slop	e	Local Relief (concave, cor	nvex, none): VV	Slope (%): 8-15%			
Subregion (LRR or MLRA):	Latitude: 4	7.6804108871 Long	itude: -95.38906794	Datum: NAD83			
Soil Map Unit Name: 38C2			NWI Clas	ssification: PSS1C			
Are climatic/hydrologic conditions on the si	te typical for this time of year	r? (if no, explain in Remark		Yes			
Are Vegetation No , Soil No , or Hydro			•				
Are Vegetation No , Soil No , or Hydrolo							
SLIMMARY OF FINDINGS - Attach site m	SUMMARY OF FINDINGS - Attach site map showing sampling point locations, transects, important features, etc.						
Hydrophytic Vegetation Present?	No	Is the Sampled Area	tant reatures, etc.

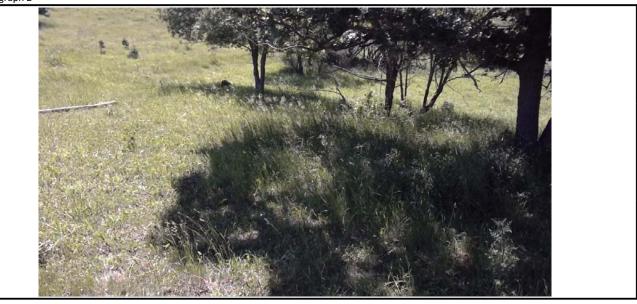
Site Photograph 2 Sampling Point: u-149n37w33-NWI

の記念が、「大きないのでは、「大きないのでは、「大きない」では、「ないない」では、「ないないない」では、「ないないない」では、「ないないない」では、「ないないないない」では、「ないないない」では、「ないないないないないないないないないない。」では、「ないないないないないないないないないないないないないないないないないないない					
Latitude: 47.6804108871591	Cowardin Classification:				
Longitude: -95.389067949816	Circular 39:				
Direction: south	Eggers & Reed:				
Remarks:					
upland
