WETLAND DETERMINATION DATA FORM - North Central and Northeast Region

Project/Site: L3R	City/County: Clear	rwater	Sampling Date: 2016-06-20			
Applicant/Owner: Enbridge		State: Minnesota	Sampling Point: u-149n37w33-ab1			
Investigator(s): DPT, ZCW	Section, To	Section, Township, Range: S33, T147N, R37W				
Landform (hillslope, terrace, etc.): Sid	e Slope	Local Relief (concave, convex, none): VV Slope (%): 8-15%				
Subregion (LRR or MLRA):	<u> </u>	Latitude: 47.6766633801 Longitude: -95.39439976 Datum: NAD83				
Soil Map Unit Name: 38C2			NWI Classification: PEMC			
Are climatic/hydrologic conditions on the site typical for this time of year? (if no, explain in Remarks): Yes						
_			· ———			
Are Vegetation Yes_, Soil No, or Hydrology No_ significantly disturbed? Are "Normal Circumstances" present? No_						
Are Vegetation No , Soil No , or Hydrology No naturally problematic? (If needed, explain any answers in Remarks)						
SUMMARY OF FINDINGS - Attach	ite map showing sampling po	oint locations, transects, imp	oortant features, etc.

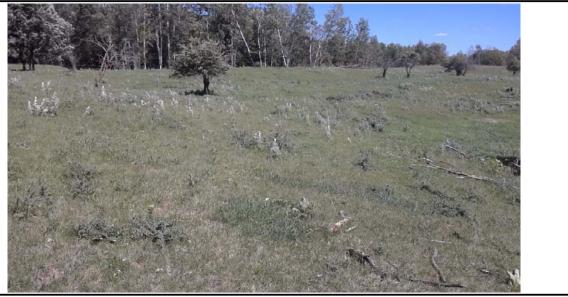
Site Photograph 1 Sampling Point: u-149n37w33-ab1

47.6766627096084	Cowardin Classification:			
-95.3945901152635	Circular 39:			
t	Eggers & Reed:			
	47.6766627096084 -95.3945901152635
