WETLAND DETERMINATION DATA FORM - North Central and Northeast Region

Project/Site: L3R	City/Cou	City/County: Clearwater			Sampling Date: 2016-07-01		
Applicant/Owner: Enbridge		Sta	ate: Minnesota	S	Sampling Point: <u>u-149</u>	n38w23-aa1	
Investigator(s): DPT, ZCW	Se	ection, Township, F	Range: <u>S23, T149</u>	N, R38W			
Landform (hillslope, terrace, etc.):	Rise	Lo	cal Relief (concav	ve, convex, none): VL	Slope	(%): 0-2%	
Subregion (LRR or MLRA):		 Latitude: 47.70	28092602	Longitude: -95.47689	—— 9462	AD83	
Soil Map Unit Name: 38C2				N	WI Classification: PEN	/IC	
Are climatic/hydrologic conditions	on the site typical for t	nis time of year? (if	f no, explain in Re		Yes		
, ,			•	•			
Are Vegetation No_, Soil No_,	or Hydrology NO sign	ificantly disturbed	? Are "Normal C	ircumstances" present	? <u>Yes</u>		
Are Vegetation No , Soil No , or Hydrology No naturally problematic? (If needed, explain any answers in Remarks)							
SUMMARY OF FINDINGS - Atta	ch site map showing sa	mpling point locat	ions, transects, i	mportant features, etc	c .

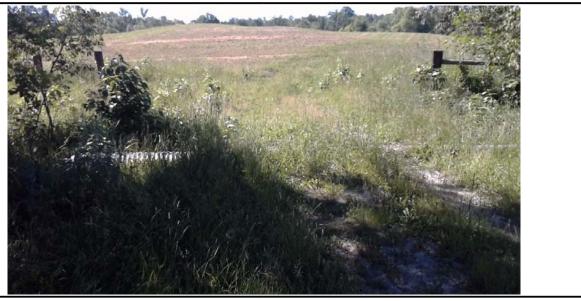
Site Photograph 1 Sampling Point: u-149n38w23-aa1

Latitude: 47.7028092602712	Cowardin Classification:
Longitude: -95.4768945370759	Circular 39:
Direction: south	Eggers & Reed:
Remarks:	
upland

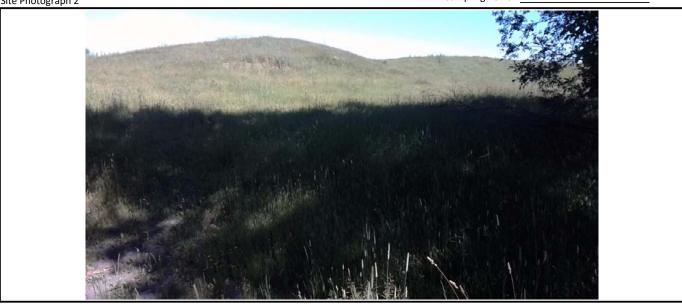
Site Photograph 2 Sampling Point: u-149n38w23-aa1

Latitude: 47.7027894789797	Cowardin Classification:
Longitude: -95.4769091215874	Circular 39:
Direction: north	Eggers & Reed:
Remarks:
