## WETLAND DETERMINATION DATA FORM - North Central and Northeast Region

Project/Site: SPP	Cit	ty/County: Clearwater	<u>r</u>	Sampling Date: 2016-07-21		
Applicant/Owner: Enbridge			State: Minnesota	Samplir	ng Point: <u>w-144n36w24-aa1</u>	
Investigator(s): ZCW		Section, Township	p, Range: <u>S 24, T 144N,</u> F	R 36W		
Landform (hillslope, terrace, etc.): Depre	ssion		Local Relief (concave, co	onvex, none): CC	Slope (%): 0-2%	
Subregion (LRR or MLRA):		 Latitude: 47	.2825185070 Lon	ngitude: -95.18667239	Datum: NAD83	
Soil Map Unit Name: 267B				NWI Cla	ssification: N/A	
Are climatic/hydrologic conditions on the	site typica	al for this time of year	? (if no. explain in Remar		Yes	
Are Vegetation No , Soil No , or Hydrology No naturally problematic? (If needed, explain any answers in Remarks)						
SUMMARY OF FINDINGS - Attach site						
Hydrophytic Vegetation Present?		No	Is the Sampled Area			
Hydric Soil Present?		No	within a Wetland?		Yes	
Wetland Hydrology Present?		Yes	If yes, optional Wetland	l Site ID:	w-144n36w24-aa

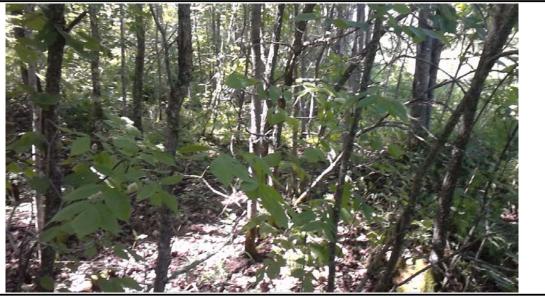
Site Photograph 1 Sampling Point: w-144n36w24-aa1

Latitude:	47.2824989771911	Cowardin Classification: PFO
Longitude:	-95.1866931841664	Circular 39: 1
Direction: East	:	Eggers & Reed: Seasonally Flooded Basin
Remarks:

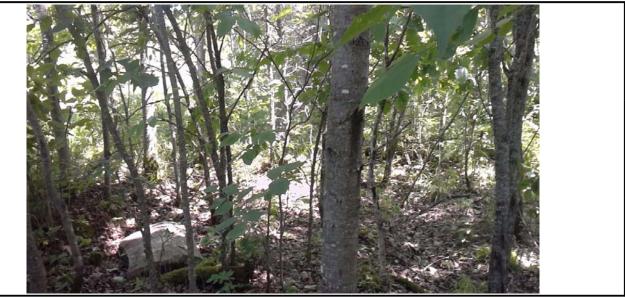
Site Photograph 2 Sampling Point: w-144n36w24-aa1

Latitude: 47.2824989771911	Cowardin Classification: PFO
Longitude: -95.1866932679854	Circular 39: 1
Direction: West	Eggers & Reed: Seasonally Flooded Basin
Remarks:
