WETLAND DETERMINATION DATA FORM - North Central and Northeast Region

Project/Site: SPP	City/County: Clearwate	<u>:r</u>	Sampling Date: 2016-07-21		
Applicant/Owner: Enbridge		State: Minnesota	Sampling Point: w-144n36w24-ac1		
Investigator(s): ZCW	Section, Townshi	ip, Range: S 24, T 144N, R 36W			
Landform (hillslope, terrace, etc.): Depres	ssion	Local Relief (concave, convex, n	none): CC Slope (%): 0-2%		
Subregion (LRR or MLRA):		•	: -95.18451020 Datum: NAD83		
Soil Map Unit Name: 267B			NWI Classification: N/A		
Are climatic/hydrologic conditions on the	e site typical for this time of year	? (if no. explain in Remarks):	Yes		
Are Vegetation No , Soil No , or Hyd	drology No significantly disturb	oed? Are "Normal Circumstance	es" present? Yes		
Are Vegetation No , Soil No , or Hydro	ology No naturally problemati	c? (If needed, explain any answ	vers in Remarks)

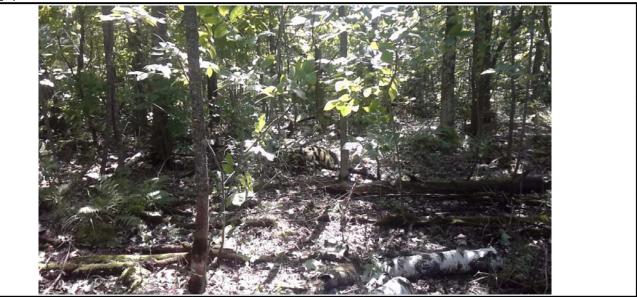
Site Photograph 1 Sampling Point: w-144n36w24-ac1

The second secon	
Latitude:	47.2825445328348	Cowardin Classification: PFO
Longitude:	-95.184511710047	Circular 39: 1
Direction: Sout	ch	Eggers & Reed: Seasonally Flooded Basin
Remarks:

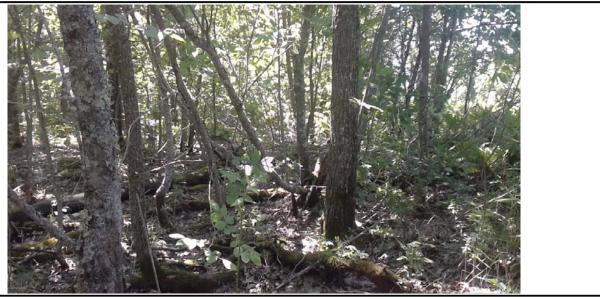
Site Photograph 2 Sampling Point: w-144n36w24-ac1

A STATE OF THE STA
Latitude:	47.2825444909253	Cowardin Classification: PFO
Longitude:	-95.184511710047	Circular 39: 1
Direction: Wes	st	Eggers & Reed: Seasonally Flooded Basin
Remarks:
