WETLAND DETERMINATION DATA FORM - North Central and Northeast Region

Project/Site: SPP	City/County: Clearwater		Sampling Date: 2016-06-30
Applicant/Owner: Enbridge		State: Minnesota	Sampling Point: w-146n36w32-ab1
Investigator(s): ZCW, DPT	Section, Township, Range: S32, T146N, 36W		
Landform (hillslope, terrace, etc.): Depression	<u> </u>	Local Relief (concave, convex	, none): CC Slope (%): 0-2%
Subregion (LRR or MLRA):	 Latitude: 4	•	e: -95.28429214 Datum: NAD83
Soil Map Unit Name: 125			NWI Classification: PSS1C
Are climatic/hydrologic conditions on the site	typical for this time of year	? (if no. explain in Remarks):	Yes
Are Vegetation No_, Soil No_, or Hydrolog	gy <u>NO</u> significantly distur	oed? Are "Normal Circumstan	ces present? res
Are Vegetation No_, Soil No_, or Hydrology	No naturally problemati	c? (If needed, explain any ans	wers in Remarks)
SUMMARY OF FINDINGS - Attach site map	showing sampling point lo	cations, transects, important	features, etc.
Hydrophytic Vegetation Present?	Yes	Is the Sampled Area

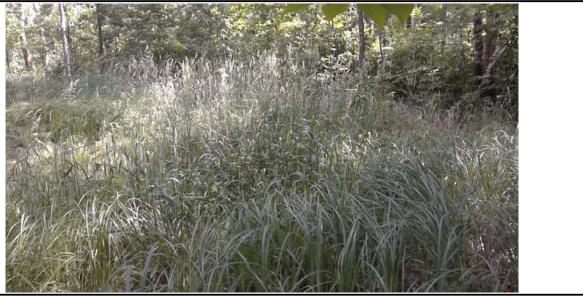
Site Photograph 1 Sampling Point: w-146n36w32-ab1

Latitude: 47.4249581387708	Cowardin Classification: PEM
Longitude: -95.2842102573209	Circular 39: 2
Direction: South	Eggers & Reed: Fresh (Wet) Meadow
Remarks:

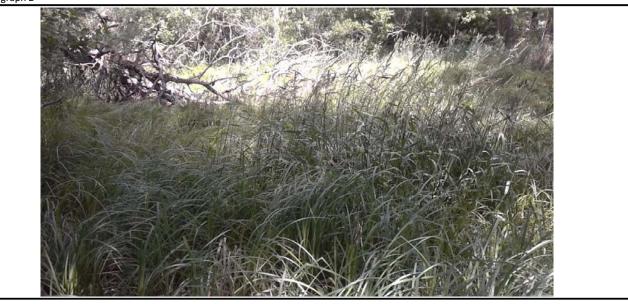
Site Photograph 2 Sampling Point: w-146n36w32-ab1

Latitude: 47.4249579711328	Cowardin Classification: PEM	
Longitude: -95.2842100896829	Circular 39: 2	
Direction: east	Eggers & Reed: Fresh (Wet) Meadow	
Remarks:
