WETLAND DETERMINATION DATA FORM - North Central and Northeast Region

Project/Site: L3R	City/County: Clearwate	er	Sampling Date: 2016-06-20				
Applicant/Owner: Enbridge		State: Minnesota	Samplin	g Point: <u>w-149</u> n37w28-aa1			
Investigator(s): ZCW/DPT	Section, Townsh	ip, Range: S28, T149N, R37	'W				
Landform (hillslope, terrace, etc.): Depress	sion	Local Relief (concave, con	vex, none): CC	Slope (%): 0-2%			
Subregion (LRR or MLRA):	Latitude: 4	7.6884687878 Longi	itude: -95.40754954	Datum: NAD83			
Soil Map Unit Name: 765			NWI Clas	ssification: N/A			
Are climatic/hydrologic conditions on the s	site typical for this time of yea	r? (if no, explain in Remarks	s):	Yes			
Are Vegetation No , Soil No , or Hydro							
Are Vegetation No_, Soil No_, or Hydrology No_ naturally problematic? (If needed, explain any answers in Remarks) SUMMARY OF FINDINGS - Attach site map showing sampling point locations, transects, important features, etc.							
Hydrophytic Vegetation Present?	Yes	Is the Sampled Area	ant leatures, etc.

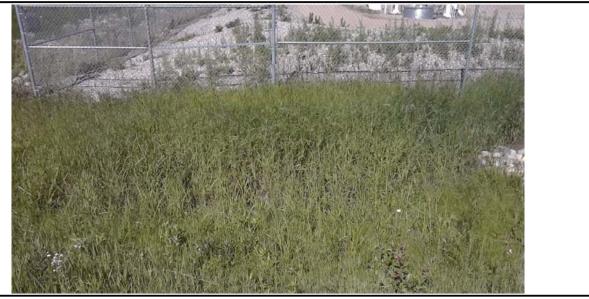
Site Photograph 1 Sampling Point: w-149n37w28-aa1

是一个人,我们就是一个人,我们就是一个人,我们就是一个人,我们就是一个人,我们就是一个人,我们就是一个人,我们就是一个人,我们就是一个人,他们就是一个人,他们就			
Latitude: 47.6884996332672	Cowardin Classification: PEM		
Longitude: -95.4075320252174	Circular 39: 2		
Direction: West	Eggers & Reed: Fresh (Wet) Meadow		
Remarks:

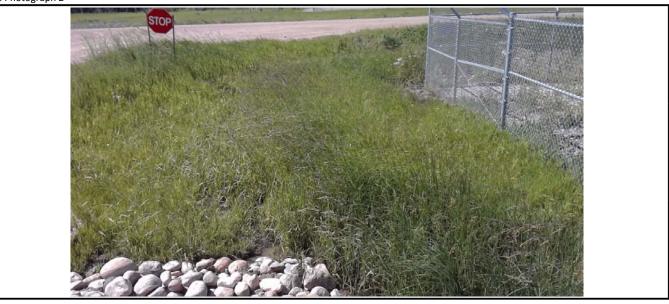
Site Photograph 2 Sampling Point: w-149n37w28-aa1

Latitude: 47.6885005971861	Cowardin Classification: PEM		
Longitude: -95.4075318575794	Circular 39: 2		
Direction: South	Eggers & Reed: Fresh (Wet) Meadow		
Remarks:
