**WETLAND DETERMINATION DATA FORM - North Central and Northeast Region**

Project/Site: L3R City/County: Clearwater Sampling Date: 2016-06-30  
 Applicant/Owner: Enbridge State: Minnesota Sampling Point: w-149n37w29-a8  
 Investigator(s): DPT, ZCW Section, Township, Range: S29, T149N, R37W  
 Landform (hillslope, terrace, etc.): Depression Local Relief (concave, convex, none): CL Slope (%): 0-2%  
 Subregion (LRR or MLRA): \_\_\_\_\_ Latitude: 47.6924824621... Longitude: -95.41167696... Datum: NAD83  
 Soil Map Unit Name: 582 NWI Classification: N/A  
 Are climatic/hydrologic conditions on the site typical for this time of year? (if no, explain in Remarks): Yes  
 Are Vegetation No, Soil No, or Hydrology No significantly disturbed? Are "Normal Circumstances" present? Yes  
 Are Vegetation No, Soil No, or Hydrology No naturally problematic? (If needed, explain any answers in Remarks)

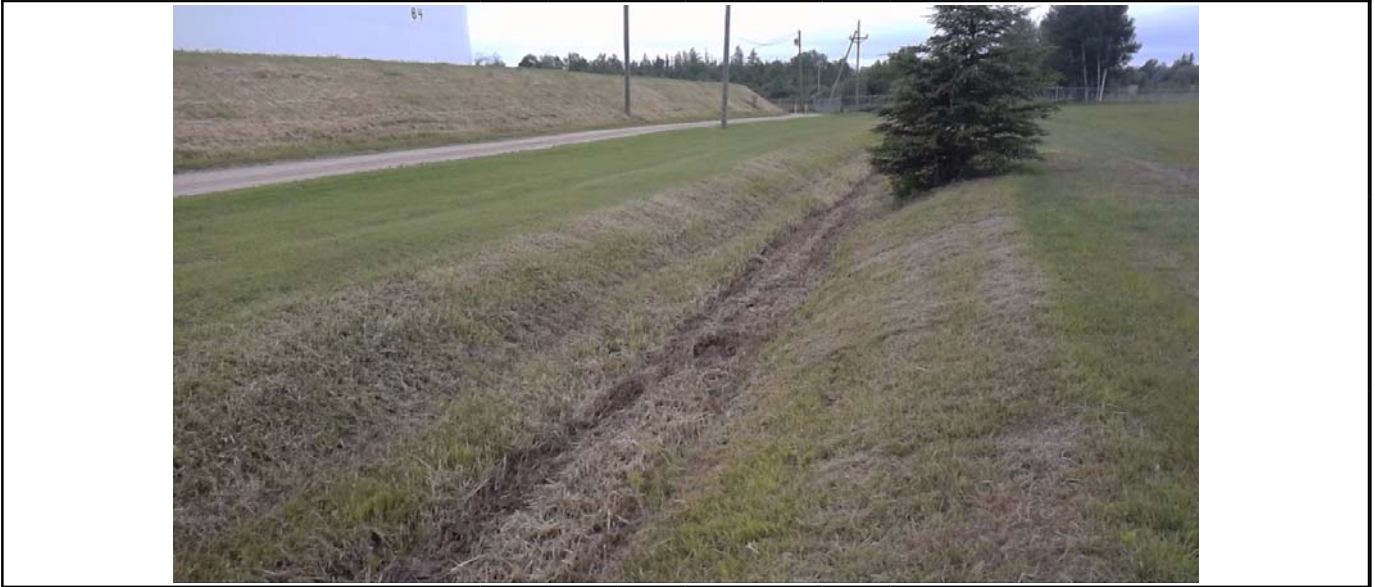
Site Photograph 1

Sampling Point: w-149n37w29-a8

Cowardin Classification: PEM

Direction: west

Eggers & Reed: Fresh (Wet) Meadow

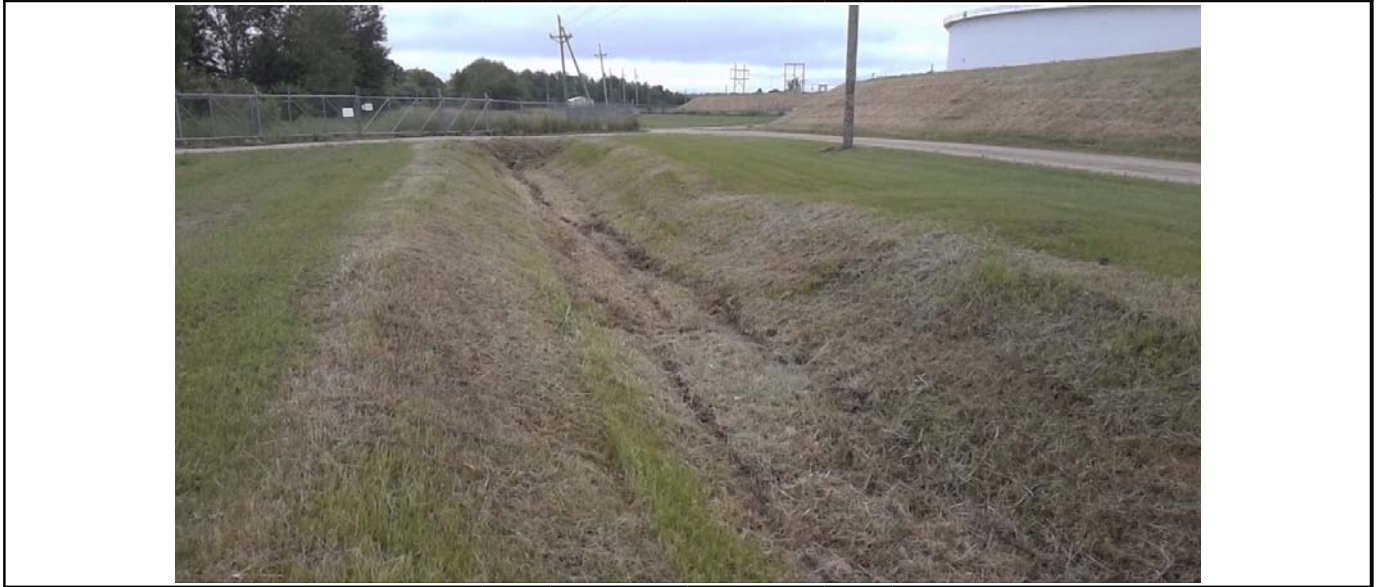
Site Photograph 2

Sampling Point: w-149n37w29-a8

Cowardin Classification: PEM

Direction: east

Eggers & Reed: Fresh (Wet) Meadow
