WETLAND DETERMINATION DATA FORM - North Central and Northeast Region

Project/Site: L3R	C	ity/County: Clearwater	<u>r</u>	Sampling Date: 2016-06-20		
Applicant/Owner: Enbridge			State: Minnesota	Samplir	ng Point: <u>w-149n37w33-aa1</u>	
Investigator(s): DPT, ZCW		Section, Townshi	p, Range: <u>S33, T149N, R</u>	R37W		
Landform (hillslope, terrace, etc.): Depre	ession		Local Relief (concave, c	convex, none): CC	Slope (%): 0-2%	
Subregion (LRR or MLRA):		Latitude: 47	7.6876884745 Lo	ngitude: -95.38814443	Datum: NAD83	
Soil Map Unit Name: 1699A				NWI Cla	ssification: N/A	
Are climatic/hydrologic conditions on th	e site typic	cal for this time of year	? (if no, explain in Rema	- ırks):	Yes	
Are Vegetation No_, Soil No_, or Hydrology No_ significantly disturbed? Are "Normal Circumstances" present? Yes_						
Are Vegetation No_, Soil No_, or Hydrology No_ naturally problematic? (If needed, explain any answers in Remarks)						
SUMMARY OF FINDINGS - Attach site	e map shov	wing sampling point lo	cations, transects, impo	ortant features, etc.

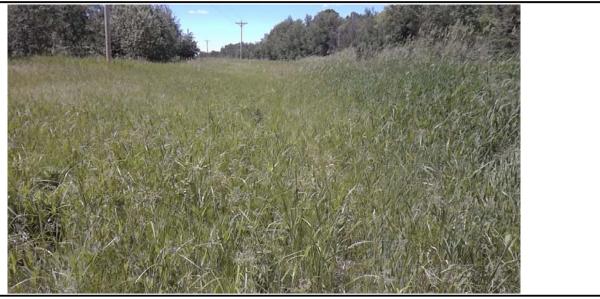
Site Photograph 1 Sampling Point: w-149n37w33-aa1

Latitude: 47.6876805117798	Cowardin Classification: PEM		
Longitude: -95.3881433420772	Circular 39: 2		
Direction: West	Eggers & Reed: Fresh (Wet) Meadow		
Remarks:

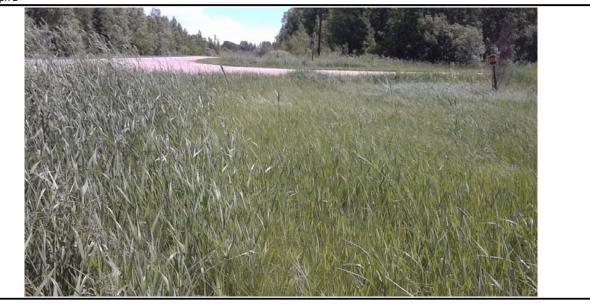
Site Photograph 2 Sampling Point: w-149n37w33-aa1

Latitude: 47.6876782067564	Cowardin Classification: PEM			
Longitude: -95.3881462757433	Circular 39: 2			
Direction: East	Eggers & Reed: Fresh (Wet) Meadow			
Remarks:
