| WETLA | ND DETE | RMINATION DATA F | ORM - North Cen | tral and Northeas | st Region | | | |
| Project/Site: L3R City/County: Clearwater | | | | - | Sampling Date: 2016-06-20 | | | |
| Applicant/Owner: Enbridge | icant/Owner: Enbridge State: Minnesota | | | | Sampling Point: w-149n37w33-l2 | | | |
| SUMMARY OF FINDINGS - Attach site map showing sampling point locations, transects, important features, etc. | | | | | | | | |

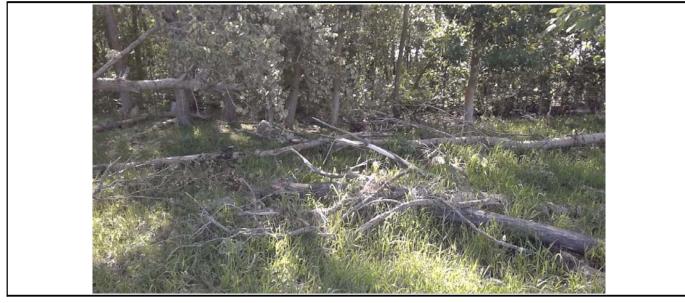
Site Photograph 1

Cowardin Classification: PFO

Circular 39: 1

Direction: west

Eggers & Reed: Seasonally Flooded Basin

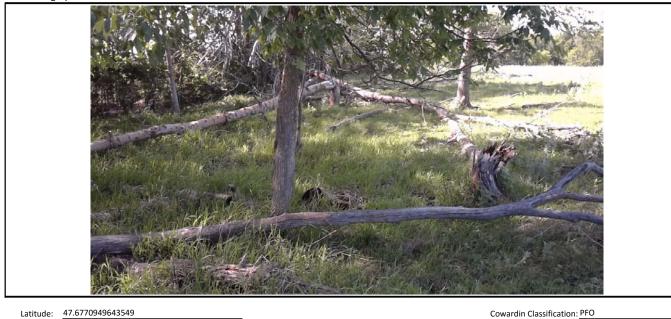
Site Photograph 2

Direction: north

Circular 39: 1

Eggers & Reed: Seasonally Flooded Basin
