WETLAN			ORM - North Cent	tral and Nor	theast Region		
Project/Site: L3R	_ City/C	City/County: Clearwater			Sampling Date: 2016-06-21		
Applicant/Owner: Enbridge		State: Minnesota			Sampling Point: w-149n37w34-aa1		
Investigator(s): ZCW, DPT			o, Range: S 34, T 149	9, R 34W			
Landform (hillslope, terrace, etc.): Depressi	ion		Local Relief (concav	ve, convex, no	one): CC	Slope (%)	_ :0-2%
Subregion (LRR or MLRA):			.677583964586		-95.38644508	Datum: NAD8	
Soil Map Unit Name: 38C2						cation: PSS1C	
Are climatic/hydrologic conditions on the s	ite typical for	this time of year?	? (if no, explain in Re	emarks):		Yes	
Are Vegetation <u>No</u> , Soil <u>No</u> , or Hydro	ology <u>No</u> si	gnificantly disturb	ed? Are "Normal Ci	ircumstances'	" present? Yes		
Are Vegetation <u>No</u> , Soil <u>No</u> , or Hydrold	ogy <u>No</u> nat	urally problematic	? (If needed, expla	in any answe	rs in Remarks)		
SUMMARY OF FINDINGS - Attach site m	nap showing	sampling point lo	cations, transects, i	mportant fea	tures, etc.

Sampling Point: w-149n37...

Northcentral and Northeast Region – Version 2.0

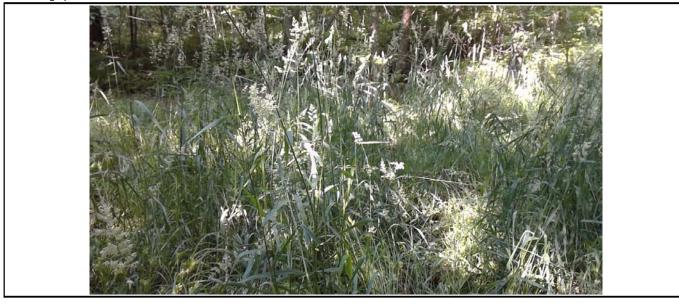
Site Photograph 1

Cowardin Classification: PEM

Circular 39: 1

Direction: West

Eggers & Reed: Seasonally Flooded Basin

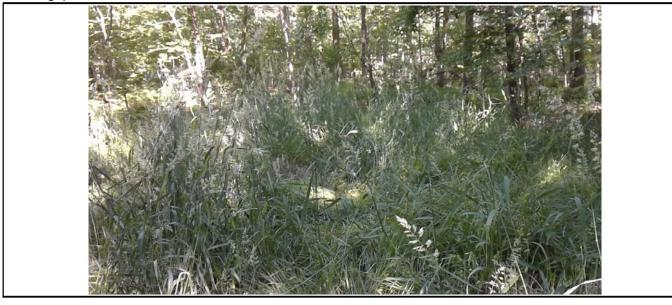
Site Photograph 2

Cowardin Classification: PEM

Circular 39: 1

Direction: North

Eggers & Reed: Seasonally Flooded Basin
