WETLA	AND DETER	RMINATION DATA F	ORM - North Cent	ral and Nor	theast Region		
Project/Site: SPP	Cit	City/County: Clearwater			Sampling Date: 2016-06-21		
Applicant/Owner: Enbridge		State: Minnesota			Sampling Point: w-149n38w17-aa2		
Investigator(s): DPT, ZCW		Section, Townshi	o, Range: S17, T149N	N, R38W			
Landform (hillslope, terrace, etc.): Depre	ession		Local Relief (concave		one): CC	Slope (%): 0-2%	
Subregion (LRR or MLRA):		Latitude: 47				atum: NAD83	
Soil Map Unit Name: 582				Longitude.	NWI Classifica		
Are climatic/hydrologic conditions on th	e site typica	l for this time of year	? (if no, explain in Re	marks):		Yes	
Are Vegetation <u>No</u> , Soil <u>No</u> , or Hy				-	" procent? Yes		
Are Vegetation <u>No</u> , Soil <u>No</u> , or Hydr	ology <u>No</u>	naturally problematic	? (If needed, explai	n any answe	rs in Remarks)		
SUMMARY OF FINDINGS - Attach site	e map show	ing sampling point lo	cations, transects, in	nportant fea	tures, etc.

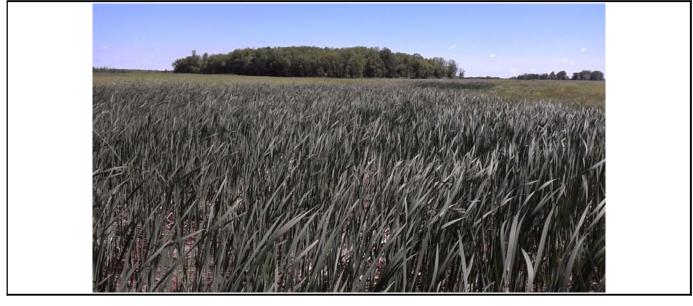
Site Photograph 1

Direction: northeast

Cowardin Classification: PEM

Circular 39: <u>3</u> Eggers & Reed: <u>Shallow Marsh</u>

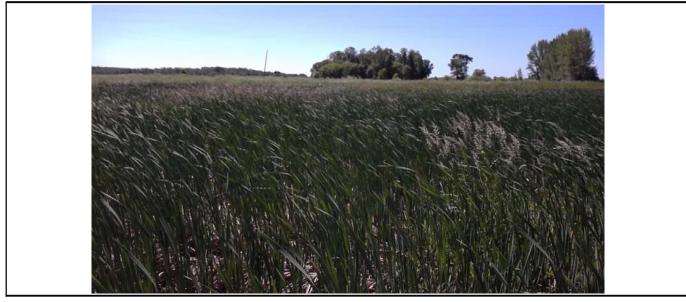
Site Photograph 2

Cowardin Classification: <u>PEM</u> Circular 39: <u>3</u>

Direction: south

Eggers & Reed: Shallow Marsh
