## WETLAND DETERMINATION DATA FORM - North Central and Northeast Region

Project/Site: SPP	_ c	City/County: Clearwater		Sampling Date: 2016-06-21	
Applicant/Owner: Enbridge			State: Minnesota	Samplir	ng Point: w-149n38w17-ab1
Investigator(s): DPT, ZCW		Section, Townshi	p, Range: S17, T149N, R3		
Landform (hillslope, terrace, etc.): Depress	sion		Local Relief (concave, co		Slope (%): 0-2%
Subregion (LRR or MLRA):		 Latitude: 47	•	gitude: -95.55957161	Datum: NAD83
Soil Map Unit Name: 582					ssification: N/A
Are climatic/hydrologic conditions on the	site tynic	al for this time of year	2 (if no evolain in Remark		Yes
Are Vegetation No , Soil No , or Hydi	rology No	<ul><li>significantly disturb</li></ul>	ped? Are "Normal Circum	nstances" present? Yes	
Are Vegetation No_, Soil No_, or Hydrol	ogy No	_ naturally problemation	c? (If needed, explain an	y answers in Remarks)	
CLIBARA A DV OF FINIDINGS. Assestants					
SUMMARY OF FINDINGS - Attach site	map show			rtant features, etc.

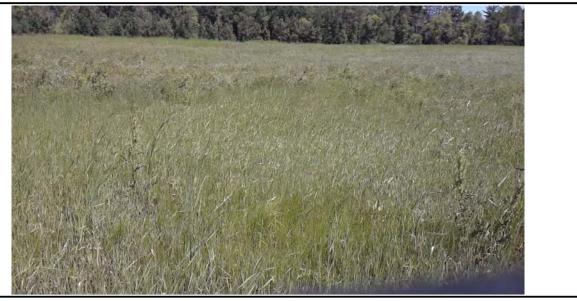
Site Photograph 1 Sampling Point: w-149n38w17-ab1

Latitude: 47.7174020279643	Cowardin Classification: PEM
Longitude: -95.5595706962939	Circular 39: 2
Direction: north	Eggers & Reed: Fresh (Wet) Meadow

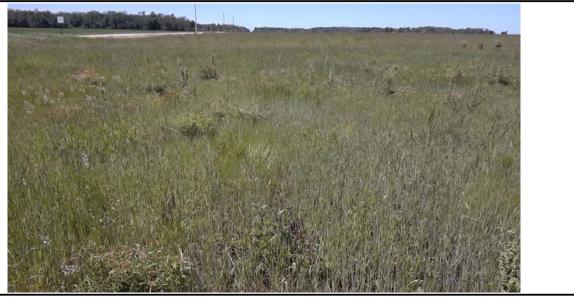
Site Photograph 2 Sampling Point: w-149n38w17-ab1

Latitude: 47.7174007287693	Cowardin Classification: PEM
Longitude: -95.5594835245009	Circular 39: 2
Direction: west	Eggers & Reed: Fresh (Wet) Meadow
