WETLAND DETERMINATION DATA FORM - North Central and Northeast Region

Project/Site: SPP City/County: Clearwater Sampling Date: 2016-06-21
 Applicant/Owner: Enbridge State: Minnesota Sampling Point: w-149n38w17-ac1
 Investigator(s): DPT, ZCW Section, Township, Range: S17, T149N, R38W
 Landform (hillslope, terrace, etc.): Depression Local Relief (concave, convex, none): CC Slope (%): 0-2%
 Subregion (LRR or MLRA): _____ Latitude: 47.7175998408... Longitude: -95.54959698... Datum: NAD83
 Soil Map Unit Name: 180 NWI Classification: N/A
 Are climatic/hydrologic conditions on the site typical for this time of year? (if no, explain in Remarks): Yes
 Are Vegetation No, Soil No, or Hydrology No significantly disturbed? Are "Normal Circumstances" present? Yes
 Are Vegetation No, Soil No, or Hydrology No naturally problematic? (If needed, explain any answers in Remarks)

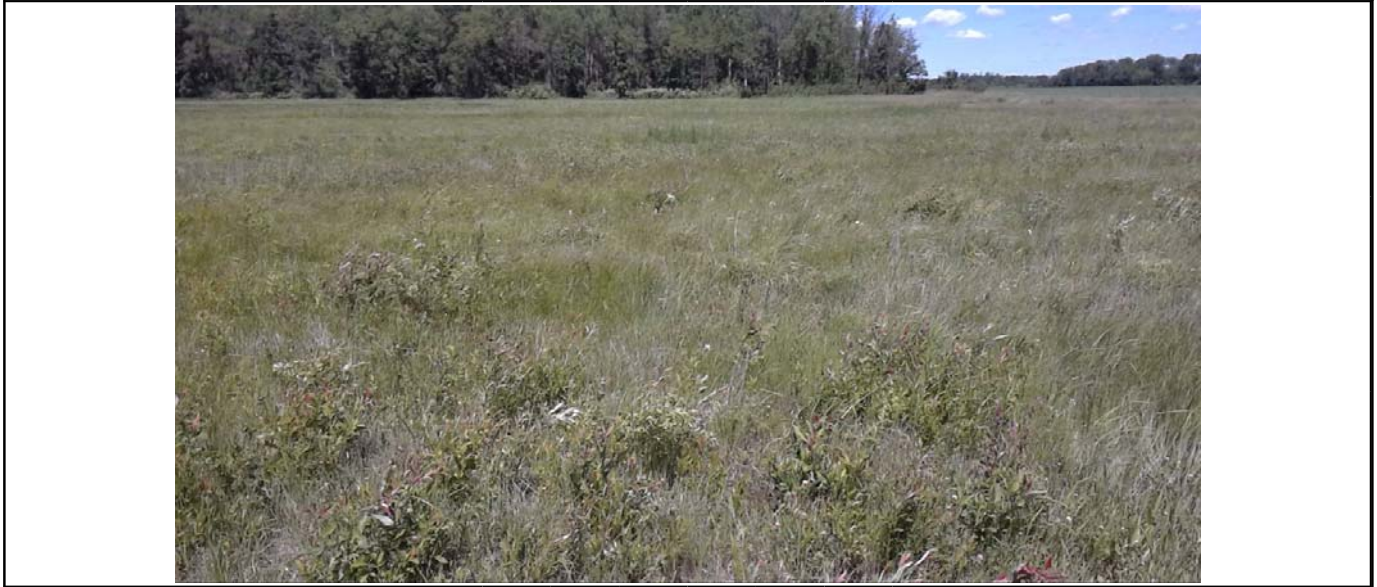
Site Photograph 1

Sampling Point: w-149n38w17-ac1

Cowardin Classification: PEM

Direction: north

Eggers & Reed: Seasonally Flooded Basin

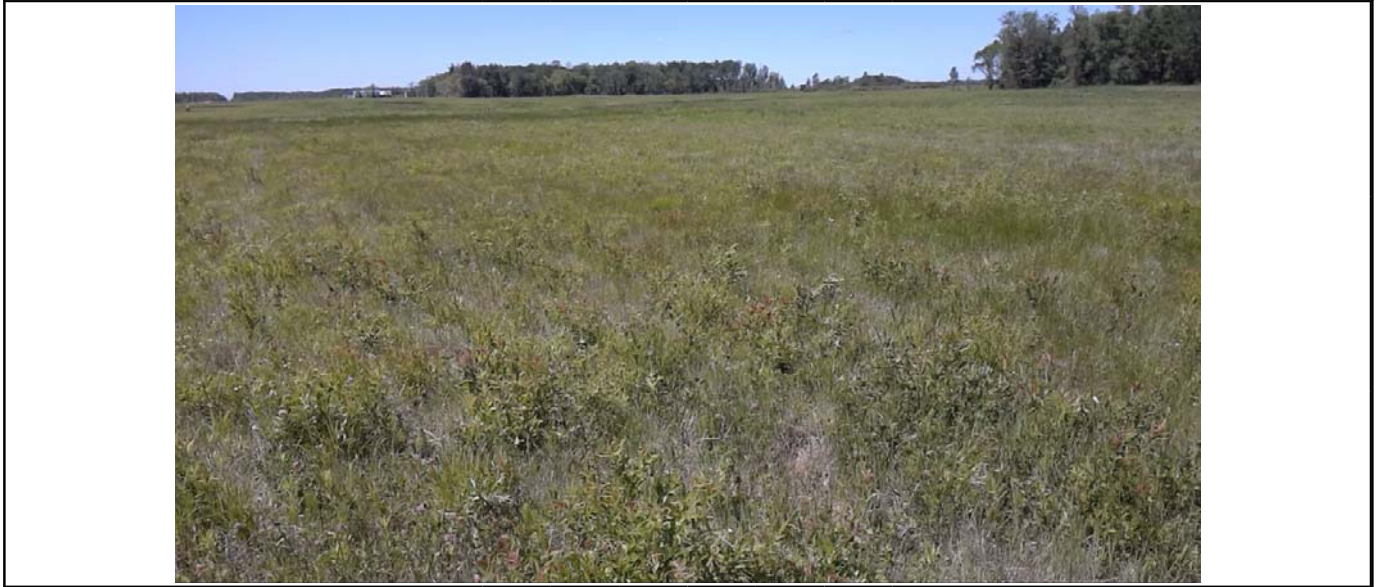
Site Photograph 2

Sampling Point: w-149n38w17-ac1

Cowardin Classification: PEM

Direction: west

Eggers & Reed: Seasonally Flooded Basin
