## WETLAND DETERMINATION DATA FORM - North Central and Northeast Region

Project/Site: SPP	City/	City/County: Hubbard		Sampling Date: 2016-07-08		
Applicant/Owner: Enbridge			State: Minnesota	s	ampling Point: u-143n3	35w32-aa1
Investigator(s): DPT, KSH		_ Section, Townshi	p, Range: <u>S32, T143</u> I	N, R35W		
Landform (hillslope, terrace, etc.): Side S	lope		Local Relief (concav	re, convex, none): VV	Slope (%	6): 3-7%
Subregion (LRR or MLRA):		 Latitude: 47	7.1608049748	Longitude: -95.13345	 5074	083
Soil Map Unit Name: 526E				N	WI Classification: PFO1	.c
Are climatic/hydrologic conditions on the	e site typical f	for this time of year	? (if no. explain in Re		Yes	
Are Vegetation No , Soil No , or Hyd		,		,	? Yes	
Are Vegetation No_, Soil No_, or Hydrology No_ naturally problematic? (If needed, explain any answers in Remarks)						
SUMMARY OF FINDINGS - Attach site	map showin	g sampling point lo	cations, transects, i	mportant features, etc	<b>.</b>	
Hydrophytic Vegetation Present?	N	0	Is the Sampled Are	a

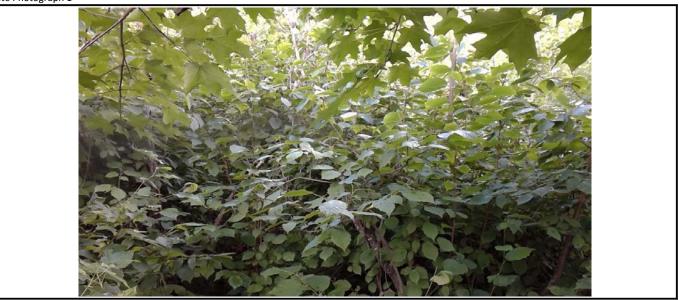
Site Photograph 1 Sampling Point: u-143n35w32-aa1

Latitude:	47.1608105907656	Cowardin Classification:
Longitude:	-95.1334527601443	Circular 39:
Direction: wes	t t	Eggers & Reed:
Remarks:		
upland

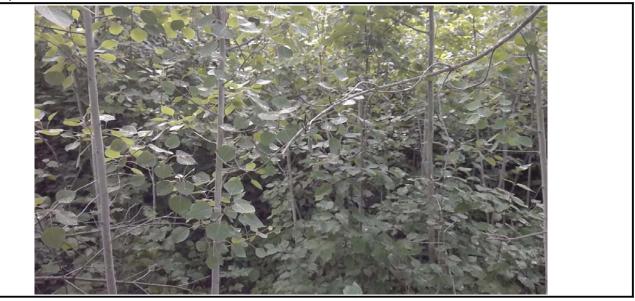
Site Photograph 2 Sampling Point: u-143n35w32-aa1

Latitude: 47.1608110098607	Cowardin Classification:
Longitude: -95.1334529277823	Circular 39:
Direction: north	Eggers & Reed:
Remarks:	
upland
