WETLAND DETERMINATION DATA FORM - North Central and Northeast Region

Project/Site: SPP	City/County: Hubba	City/County: Hubbard		Sampling Date: 2016-07-22		
Applicant/Owner: Enbridge		State: Minnesota	Samplir	ng Point: <u>u-143n35w33-aa1</u>		
Investigator(s): ZCW Section, Township, Range: S 33, T 143N, R 35W						
Landform (hillslope, terrace, etc.): Side Slo	ope	Local Relief (concave, c	onvex, none): VL	Slope (%): 3-7%		
Subregion (LRR or MLRA):	Latitude	: 47.1591225592 Loi	ngitude: -95.13057298	Datum: NAD83		
Soil Map Unit Name: 526C			NWI Cla	ssification: N/A		
Are climatic/hydrologic conditions on the site typical for this time of year? (if no, explain in Remarks): Yes						
Are Vegetation No, Soil No, or Hyd	drology No_ significantly dis	turbed? Are "Normal Circui	mstances" present? Yes			
Are Vegetation No_, Soil No_, or Hydrology No_ naturally problematic? (If needed, explain any answers in Remarks)						
SUMMARY OF FINDINGS - Attach site		<u> </u>	ortant features, etc.

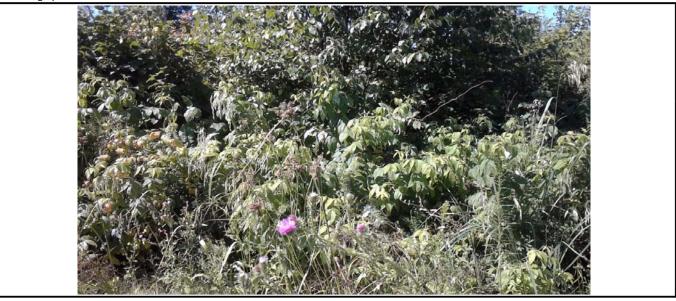
Site Photograph 2 Sampling Point: u-143n35w33-aa1

Latitude: 47.1591254	091329	Cowardin Classification:		
Longitude: -95.1305670	0385204	Circular 39:		
Direction: West		Eggers & Reed:		
Remarks:
