WETLAND DETERMINATION DATA FORM - North Central and Northeast Region

Project/Site: SPP	City/County: Hubbard		Sampling Date: 2016-07-22			
Applicant/Owner: Enbridge		State: Minnesota	Sampling Point: u-143n35w33-ab1			
Investigator(s): ZCW	Section, Townshi	ip, Range: S 33, T 143N, R 35W				
Landform (hillslope, terrace, etc.): Shoul		Local Relief (concave, convex,	none): VL Slope (%): 3-7%			
Subregion (LRR or MLRA):		,	2: -95.12769933 Datum: NAD83			
Soil Map Unit Name: 526C			NWI Classification: N/A			
Are climatic/hydrologic conditions on th	ne site typical for this time of year	? (if no explain in Remarks):	Yes			
· -						
Are Vegetation No , Soil No , or Hy	ydrology No significantly disturb	bed? Are "Normal Circumstance	es" present? Yes			
Are Vegetation No , Soil No , or Hydi	rology No naturally problemati	c? (If needed, explain any answ	wers in Remarks)			
·	- · ·	, , , , ,	,			
SUMMARY OF FINDINGS - Attach site	e map showing sampling point lo	ocations, transects, important f	eatures, etc.

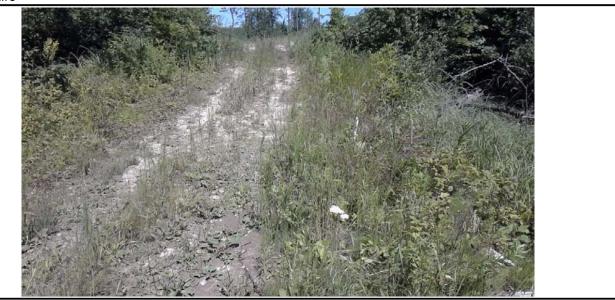
Site Photograph 1 Sampling Point: u-143n35w33-ab1

Latitude: 47.1581665613196	Cowardin Classification:			
Longitude: -95.1277259086213	Circular 39:			
Direction: North	Eggers & Reed:			
Remarks:

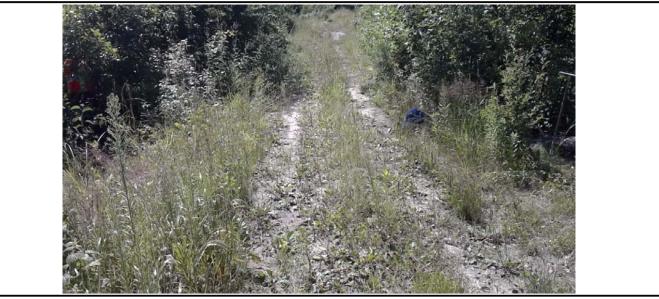
Site Photograph 2 Sampling Point: u-143n35w33-ab1

Latitude: 47.1581686987049	Cowardin Classification:			
Longitude: -95.1277272497258	Circular 39:			
Direction: South	Eggers & Reed:			
Remarks:
