WETLAND DETERMINATION DATA FORM - North Central and Northeast Region

Project/Site: SPP City/County: Hubbard Sampling Date: 2016-07-08

Applicant/Owner: Enbridge State: Minnesota Sampling Point: w-143n35w32-aa1

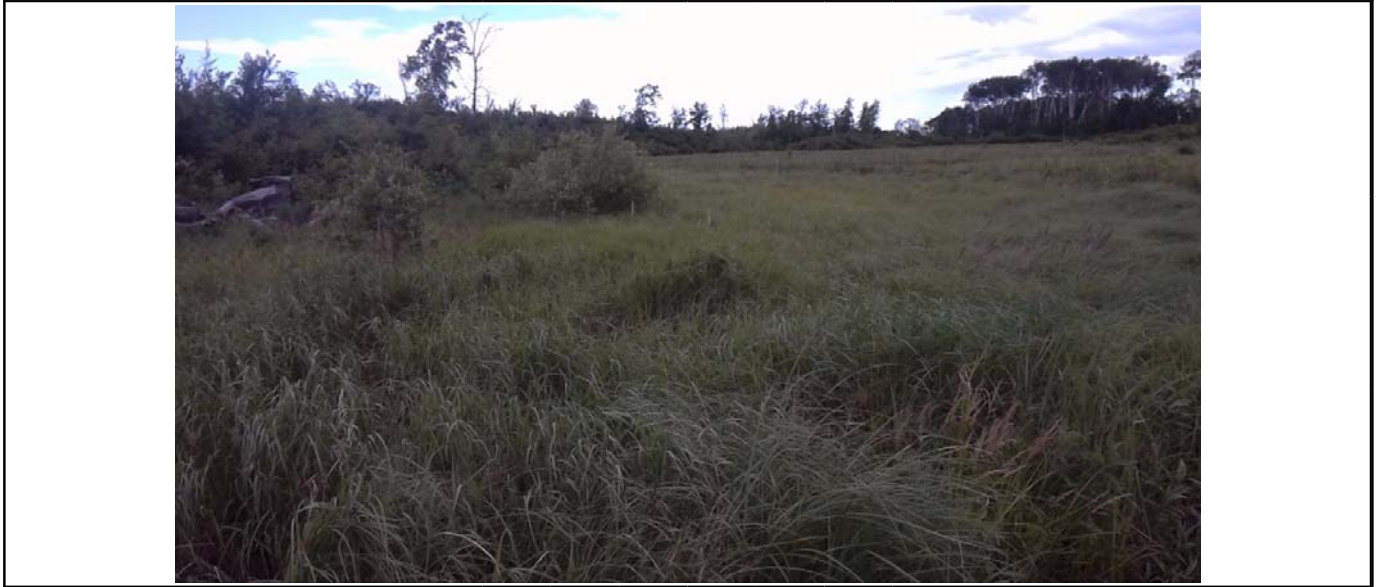
Site Photograph 1

Sampling Point: w-143n35w32-aa1

Cowardin Classification: PEM

Direction: north

Eggers & Reed: Fresh (Wet) Meadow

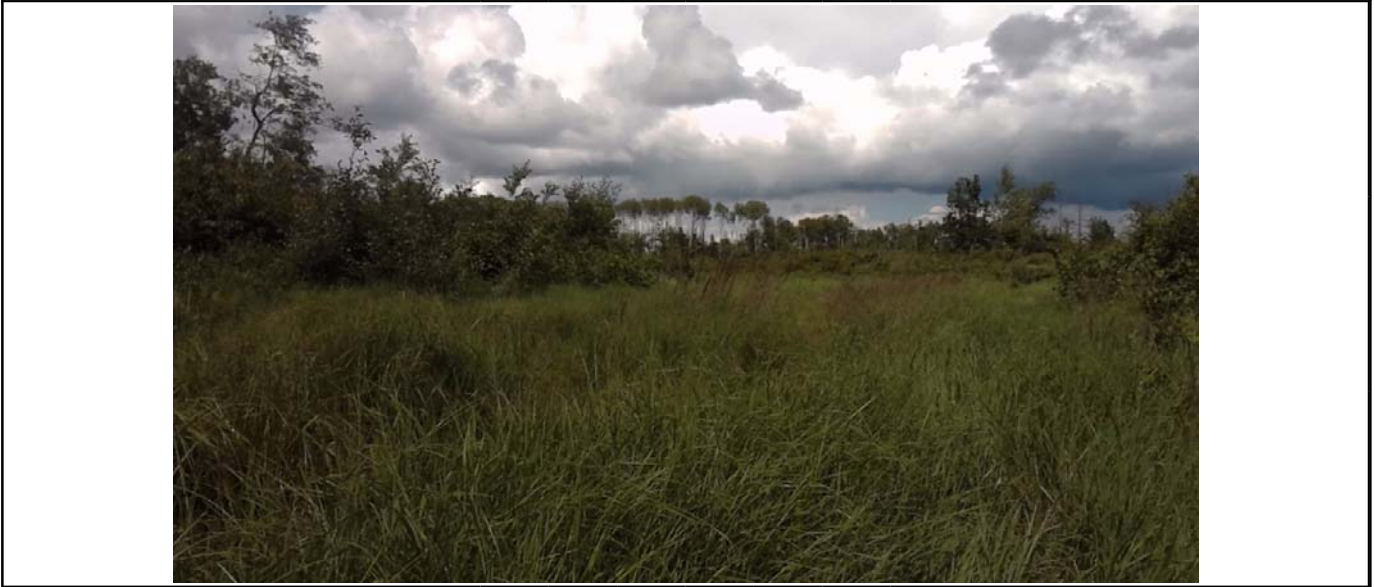
Site Photograph 2

Sampling Point: w-143n35w32-aa1

Cowardin Classification: PEM

Direction: east

Eggers & Reed: Fresh (Wet) Meadow
