WETLAND DETERMINATION DATA FORM - North Central and Northeast Region

Project/Site: SPP	City/County: Hubbard		Sampling Date: 2016-07-22	
Applicant/Owner: Enbridge		State: Minnesota	Sampling Point: w-143n35w33-ad1	
Investigator(s): ZCW	Section, Townsh	ip, Range: S 33, T 143N, R35		
Landform (hillslope, terrace, etc.): Depression	<u></u> 1	Local Relief (concave, conv	ex, none): CC Slope (%): 0-2%	
Subregion (LRR or MLRA):		•	ude: -95.13016839 Datum: NAD83	
Soil Map Unit Name: 526C			NWI Classification: PSS1C	
Are climatic/hydrologic conditions on the site	typical for this time of year	r? (if no. explain in Remarks)		
Are Vegetation No , Soil No , or Hydrold	ogy <u>No</u> significantly distur	bed? Are "Normal Circumst	ances" present? Yes	
Are Vegetation No , Soil No , or Hydrolog	y No naturally problemati	ic? (If needed, explain any a	answers in Remarks)	
<u> </u>	·			
SUMMARY OF FINDINGS - Attach site ma	p showing sampling point lo	ocations, transects, importa	nt features, etc.

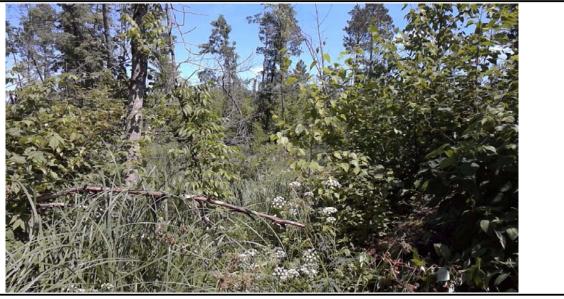
Site Photograph 1 Sampling Point: w-143n35w33-ad1

Latitude: 47.1557062631912	Cowardin Classification: PFO	
Longitude: -95.1301726699761	Circular 39: 7	
Direction: West	Eggers & Reed: Hardwood Swamp/Coniferous Swamp	
Remarks:

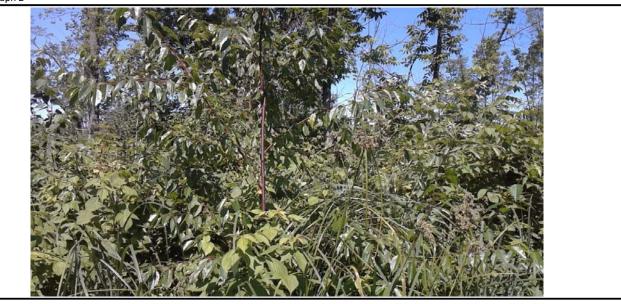
Site Photograph 2 Sampling Point: w-143n35w33-ad1

Latitude: 47.1557058021865	Cowardin Classification: PFO	
Longitude: -95.1301631146065	Circular 39: 7	
Direction: North	Eggers & Reed: Hardwood Swamp/Coniferous Swamp	
Remarks:
