WETLAND DETERMINATION DATA FORM - North Central and Northeast Region

Project/Site: SPP	City/County: Hubba	City/County: Hubbard		Sampling Date: 2016-07-22			
Applicant/Owner: Enbridge		State: Minnesota	Samplir	ng Point: w-143n35w33-af1			
Investigator(s): ZCW	Section, Towr	ship, Range: S 33, T 143N, I	 R 33W				
Landform (hillslope, terrace, etc.): Depress		Local Relief (concave, co		Slope (%): 0-2%			
Subregion (LRR or MLRA):		•	ngitude: -95.13117221	Datum: NAD83			
Soil Map Unit Name: 526C				ssification: N/A

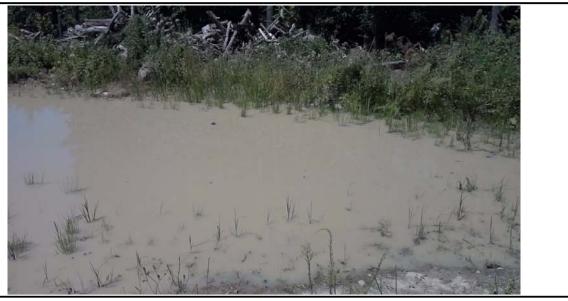
Site Photograph 1 Sampling Point: w-143n35w33-af1

Cowardin Classification: PEM		
Circular 39: 1		
Eggers & Reed: Seasonally Flooded Basin

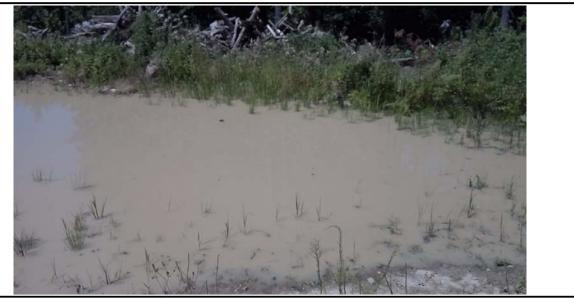
Site Photograph 2 Sampling Point: w-143n35w33-af1

Latitude:	47.1556123858757	Cowardin Classification: PEM		
Longitude:	-95.1311638300262	Circular 39:	Circular 39: 1	
Direction: Nort	th	Eggers & Reed: Seasonally Flooded Basin		
Remarks:
