**WETLAND DETERMINATION DATA FORM - North Central and Northeast Region**

Project/Site: SPP City/County: Wadena Sampling Date: 2016-07-25

Applicant/Owner: Enbridge State: Minnesota Sampling Point: w-138n33w11-aa1

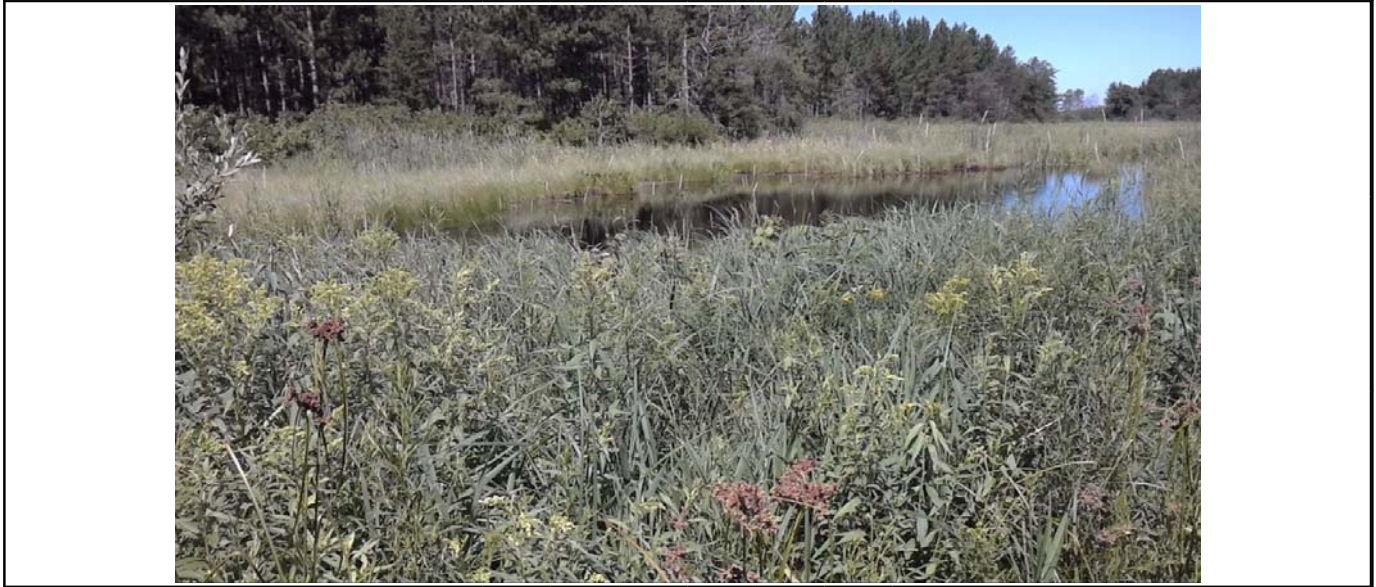
Site Photograph 1

Sampling Point: w-138n33w11-aa1

Cowardin Classification: PEM

Direction: north

Eggers & Reed: Fresh (Wet) Meadow

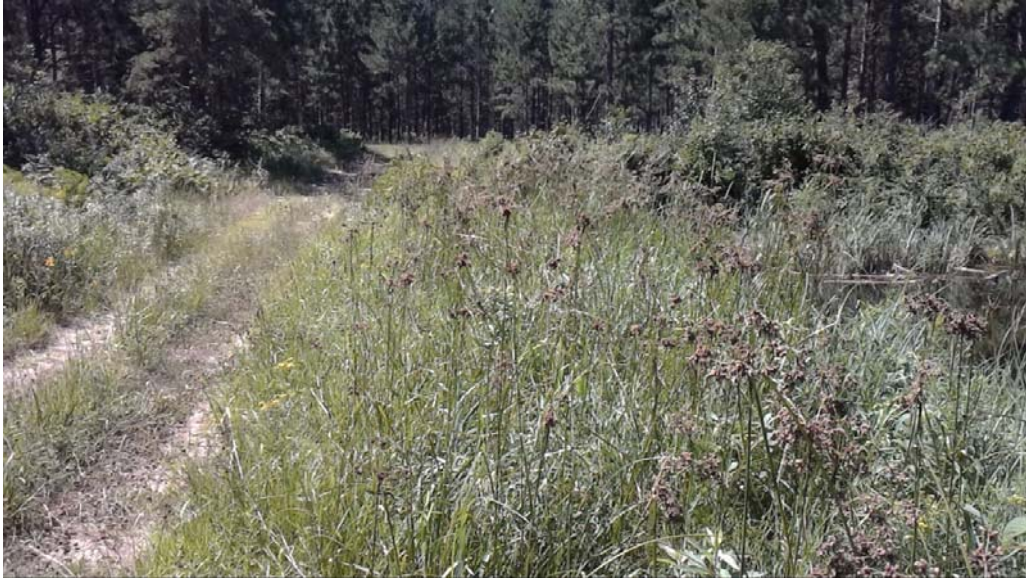
Site Photograph 2

Sampling Point: w-138n33w11-aa1

Cowardin Classification: PEM

Direction: west

Eggers & Reed: Fresh (Wet) Meadow
