## WETLAND DETERMINATION DATA FORM - North Central and Northeast Region

Project/Site: SPP	Ci	ty/County: Cass		Sampling Date: 2016-07-27		
Applicant/Owner: Enbridge			State: Minnesota	Samplin	g Point: u-139n25w18-aa1	
Investigator(s): DPT/MGH		Section, Townshi	p, Range: S18, T139N, R2	25W		
Landform (hillslope, terrace, etc.): Side S	Slope		Local Relief (concave, co		Slope (%): 3-7%	
Subregion (LRR or MLRA):		 Latitude: 46	•	gitude: -93.88945813	Datum: NAD83	
Soil Map Unit Name: 218			2011		sification: N/A	
Are climatic/hydrologic conditions on th	a sita tunica	al for this time of year	2 (if no evolain in Remark		Yes	
· ·		·	•	•		
Are Vegetation No , Soil No , or Hy	drology No	significantly disturb	ped? Are "Normal Circum	nstances" present? Yes		
Are Vegetation No , Soil No , or Hyd	rology No	naturally problemation	c? (If needed, explain an	y answers in Remarks)		
<u> </u>	u, <u></u>	- / ·	, , ,	,		
SUMMARY OF FINDINGS - Attach sit	e map show	ving sampling point lo	cations, transects, impor	rtant features, etc.

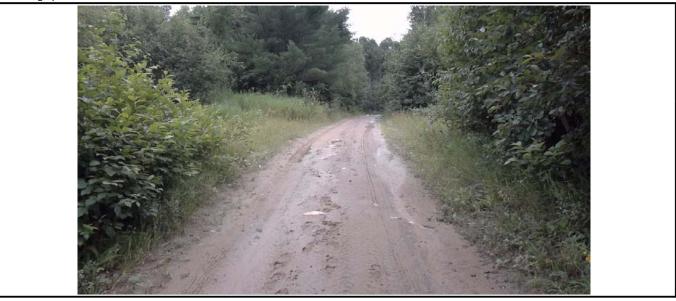
Site Photograph 1 Sampling Point: u-139n25w18-aa1

Latitude: 46.8476317171444	Cowardin Classification:
Longitude: -93.8894741424302	Circular 39:
Direction: South	Eggers & Reed:
Remarks:	
upland
