WETLAND DETERMINATION DATA FORM - North Central and Northeast Region

Project/Site: SPP	City/County: C	City/County: Cass		Sampling Date: 2016-07-29		
Applicant/Owner: Enbridge		State: Minnesota	Sampli	ng Point: <u>u-139n25w18-ac1</u>		
Investigator(s): DPT/MGH	Section,	Township, Range: S18, T13	9N, R25W			
Landform (hillslope, terrace, etc.): Rise		Local Relief (conca	ave, convex, none): VV	Slope (%): 0-2%		
Subregion (LRR or MLRA):	Lat	itude: 46.8530478515	Longitude: -93.89867512	Datum: NAD83		
Soil Map Unit Name: 146B			NWI Cl	assification: N/A		
Are climatic/hydrologic conditions on	the site typical for this tim	e of year? (if no, explain in I		Yes		
Are Vegetation No, Soil No, or H	Hydrology <u>No</u> significant	tly disturbed? Are "Normal	Circumstances" present? Yes			
Are Vegetation No , Soil No , or Hy						
SUMMARY OF FINDINGS - Attach s			-	· · · · · · · · · · · · · · · · · · ·		
Hydrophytic Vegetation Present?	No	Is the Sampled Ar				
Hydric Soil Present?	No	within a Wetland		No

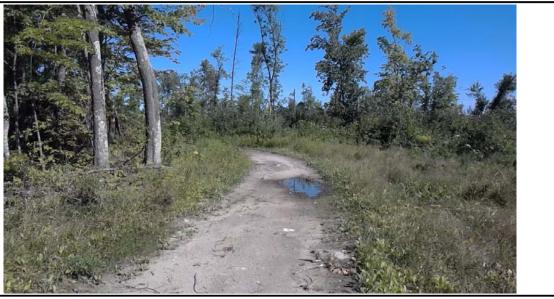
Site Photograph 1 Sampling Point: u-139n25w18-ac1

Latitude: 46.8530624360282	Cowardin Classification:			
Longitude: -93.8986217324565	Circular 39:			
Direction: South	Eggers & Reed:			
Remarks: Upland.

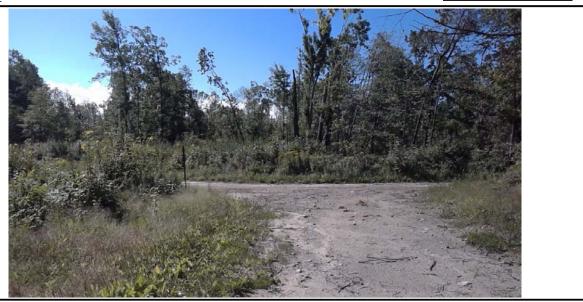
Site Photograph 2 Sampling Point: u-139n25w18-ac1

Latitude: 46.8530615559284	Cowardin Classification:			
Longitude: -93.89862315738	Circular 39:			
Direction: South	Eggers & Reed:			
Remarks:				
Upland.
