WETLAND DETERMINATION DATA FORM - North Central and Northeast Region

Project/Site: SPP	City/County: Cass		Sampling Date: 2016-07-29			
Applicant/Owner: Enbridge		State: Minnesota	Samplir	ng Point: <u>u-139n25w18-ad1</u>		
Investigator(s): DPT/MGH	Section, Townshi	ip, Range: <u>\$18,</u> T139N, R2	25W			
Landform (hillslope, terrace, etc.): Rise		Local Relief (concave, co	nvex, none): VL	Slope (%): 0-2%		
Subregion (LRR or MLRA):	 Latitude: 40	6.8559651310 Long	gitude: -93.90071502	Datum: NAD83		
Soil Map Unit Name: 540	_		NWI Cla	ssification: PUBH		
Are climatic/hydrologic conditions on the site to	pical for this time of year	? (if no, explain in Remark		Yes		
. ,		,	,			
Are Vegetation No , Soil No , or Hydrology	significantly distur	beur Are Normal Circum	istances present? res			
Are Vegetation No , Soil No , or Hydrology !	lo naturally problemati	c? (If needed, explain an	y answers in Remarks)			
SUMMARY OF FINDINGS - Attach site map s	howing sampling point lo	ocations, transects, impor	rtant features, etc.

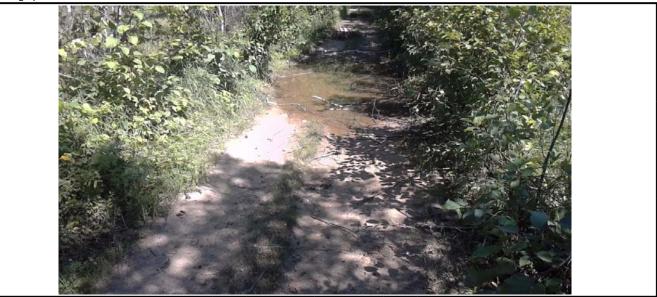
Site Photograph 1 Sampling Point: u-139n25w18-ad1

Latitude:	46.8559651310061	Cowardin Classification:
Longitude:	-93.9007150289546	Circular 39:
Direction: Nor	th	Eggers & Reed:
Remarks:		
Upland.

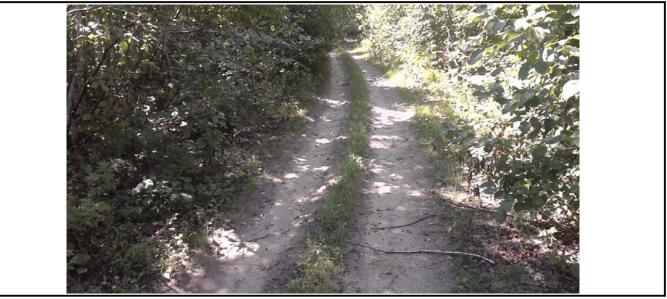
Site Photograph 2 Sampling Point: u-139n25w18-ad1

Latitude: 46.8559651310061	Cowardin Classification:
Longitude: -93.9007150289546	Circular 39:
Direction: South	Eggers & Reed:
Remarks:	
Upland.
