WETLAND DETERMINATION DATA FORM - North Central and Northeast Region

Project/Site: SPP	City	City/County: Cass		Sampling Date: 2016-08-02		
Applicant/Owner: Enbridge			State: Minnesota	Sampli	ng Point: <u>u-139n25w18-af1</u>	
Investigator(s): DPT/MGH		Section, Townshi	p, Range: <u>\$18,</u> T139N	, R25W		
Landform (hillslope, terrace, etc.):	Rise		Local Relief (concave	, convex, none): VV	Slope (%): <u>0-2%</u>	
Subregion (LRR or MLRA):		Latitude: 46	5.8513433915	Longitude: -93.88801191	Datum: NAD83	
Soil Map Unit Name: 144B		_		NWI Cla	assification: N/A	
Are climatic/hydrologic conditions	on the site typical	for this time of year	? (if no, explain in Rer	— narks):	Yes	
Are Vegetation No , Soil No ,	or Hydrology <u>No</u>	_ significantly disturb	oed? Are "Normal Cir	cumstances" present? Yes		
Are Vegetation No_, Soil No_, o	r Hydrology No	naturally problemation	c? (If needed, explain	n any answers in Remarks)		
SUMMARY OF FINDINGS - Atta	ch site map showi	ng sampling point lo	cations, transects, im	nportant features, etc.

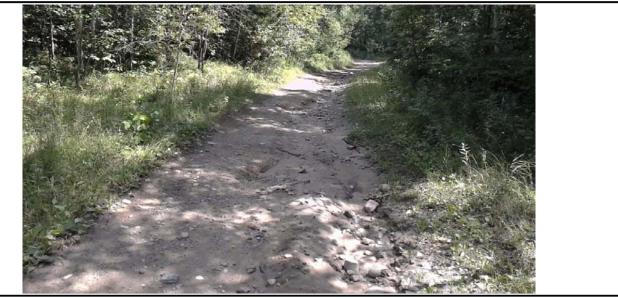
Site Photograph 1 Sampling Point: u-139n25w18-af1

Latitude: 46.8512996379722	Cowardin Classification:		
Longitude: -93.8879937306921	Circular 39:		
Direction: north	Eggers & Reed:		
Remarks:			
Upland.

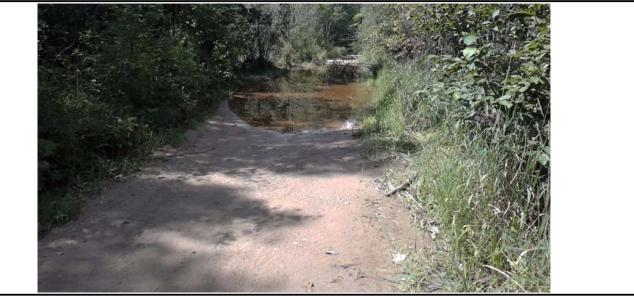
Site Photograph 2 Sampling Point: u-139n25w18-af1

Latitude: 46.8513195449923	Cowardin Classification:		
Longitude: -93.8879985083769	Circular 39:		
Direction: south	Eggers & Reed:		
Remarks:			
Upland.
