## WETLAND DETERMINATION DATA FORM - North Central and Northeast Region

Project/Site: SPP	City/County: Cass		Sampling Date: 2016-07-27		
Applicant/Owner: Enbridge		State: Minnesota	Sampling Point: u-139n25w19-ac1		
Investigator(s): DPT/MGH	Section, Townshi	ip, Range: S19, T139N, R25	W		
Landform (hillslope, terrace, etc.): Rise		Local Relief (concave, con	vex, none): CL Slope (%): 0-2%		
Subregion (LRR or MLRA):	 Latitude: 40	6.8364019785 Longi	tude: -93.88692964 Datum: NAD83		
Soil Map Unit Name: 202	_		NWI Classification: PFO4/2B		
Are climatic/hydrologic conditions on the site t	pical for this time of year	? (if no, explain in Remarks			
. , .		,	·		
Are Vegetation No , Soil No , or Hydrolog	significantly distur	bed? Are "Normal Circums	tances" present? Yes		
Are Vegetation No , Soil No , or Hydrology	No naturally problemati	c? (If needed, explain any	answers in Remarks)		
			·		
SUMMARY OF FINDINGS - Attach site map	howing sampling point lo	ocations, transects, import	ant features, etc.

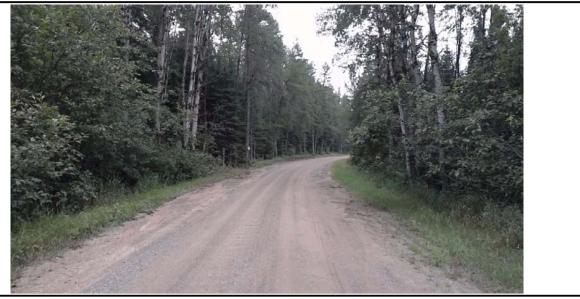
Site Photograph 1 Sampling Point: u-139n25w19-ac1

Latitude:	46.8362540379603	Cowardin Classification:			
Longitude:	-93.8865147438775	Circular 39:			
Direction: South		Eggers & Reed:			
Remarks:					
Upland.

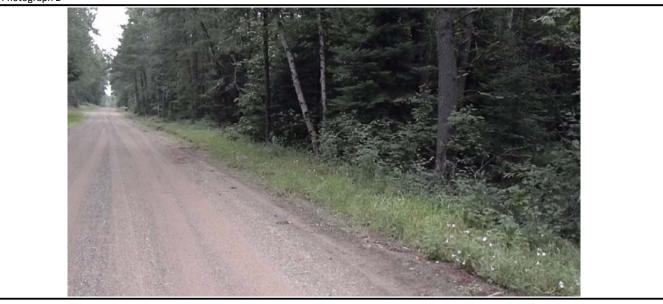
Site Photograph 2 Sampling Point: u-139n25w19-ac1

Latitude: 46.8362539122317	Cowardin Classification:
Longitude: -93.8865145762394	Circular 39:
Direction: North	Eggers & Reed:
Remarks:	
Upland.
