WETLAND DETERMINATION DATA FORM - North Central and Northeast Region

Project/Site: SPP	City/County: Cass	City/County: Cass		Sampling Date: 2016-08-03	
Applicant/Owner: Enbridge		State: Minnesota	Samplii	ng Point: <u>u-139n25w4-aa2</u>	
Investigator(s): DPT, MGH Section, Township, Range: S4, T139N, R25W					
Landform (hillslope, terrace, etc.): Rise		Local Relief (concave	, convex, none): VV	Slope (%): 0-2%	
Subregion (LRR or MLRA):	Latitu	de: 46.8766679289	Longitude: -93.84156418	Datum: NAD83	
Soil Map Unit Name: 146B			NWI Cla	ssification: N/A

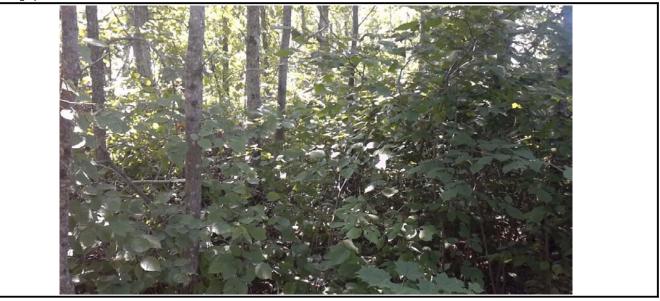
Site Photograph 1 Sampling Point: u-139n25w4-aa2

AND THE WALLY	
Latitude:	46.8766882131313	Cowardin Classification:
Longitude:	-93.8415492699424	Circular 39:
Direction: wes	t	Eggers & Reed:
Remarks:		
Upland

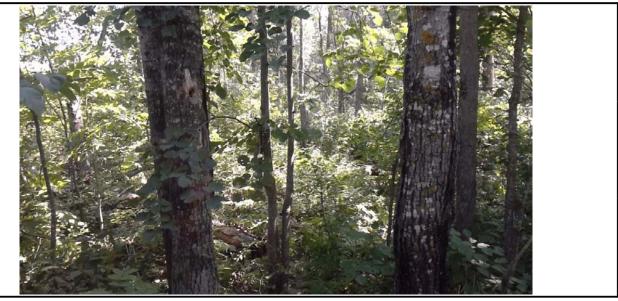
Site Photograph 2 Sampling Point: u-139n25w4-aa2

Latitude: 46.8766891351406	Cowardin Classification:			
Longitude: -93.8415496890376	Circular 39:			
Direction: east	Eggers & Reed:			
Remarks:				
Upland
